# Lessons Learned from Mine Disasters: New Technologies and Guidelines to Prevent Mine Disasters and Improve Safety

By Jürgen F. Brune and Benjamin Goertz

## A Research Report

Colorado School of Mines, Mining Engineering Department

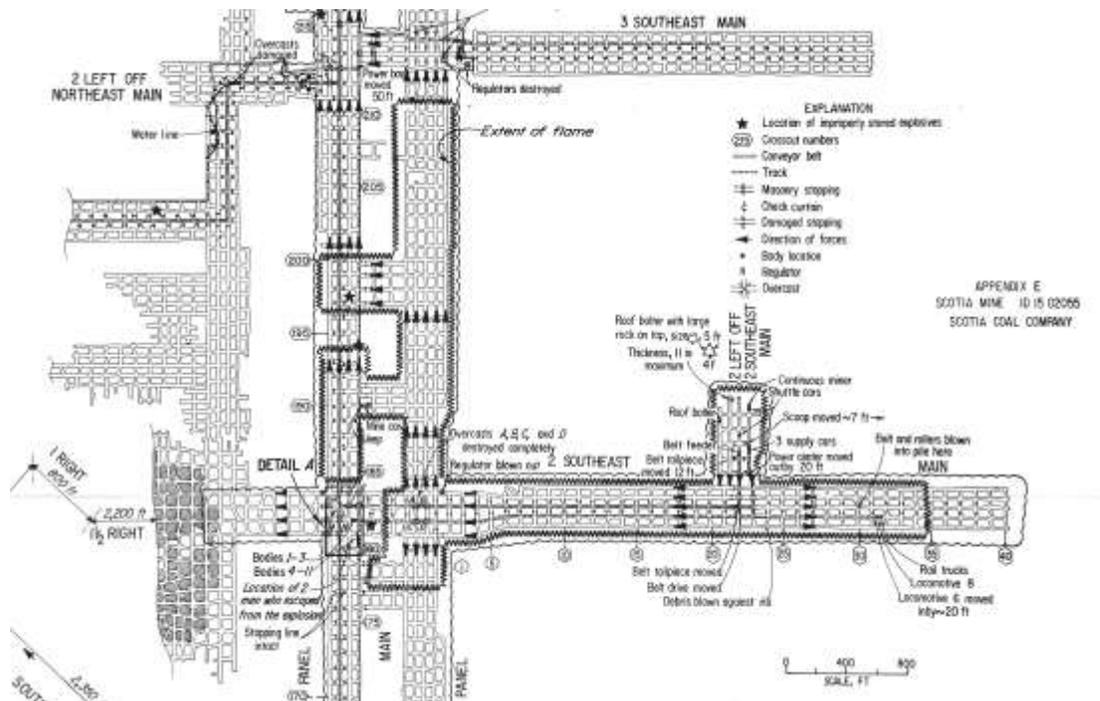
Figure 3: Extract of Scotia Mine map showing extent of flame (Michael et al., 1993)

identified, with the most likely being an electric arc or spark from a battery powered locomotive that had not been kept in permissible condition.

There were a number of major factors that lead to the occurrence of these two explosions. Activities had ceased in the 2 Left section but changes had not been made to correct the adjustment in the ventilation airflow that restricted movement into the 2 Southeast Main section. During the shift examination the miner decided to check the abandoned 2 Left area and found a regulator open 4 feet wider than it had been set previously. Approximately two minutes before the first explosion one of the miners had conducted an air test in the 2 Southeast Main and found and insufficient ventilation air quantity. Inadequate rock dusting increased the severity of the second explosion.

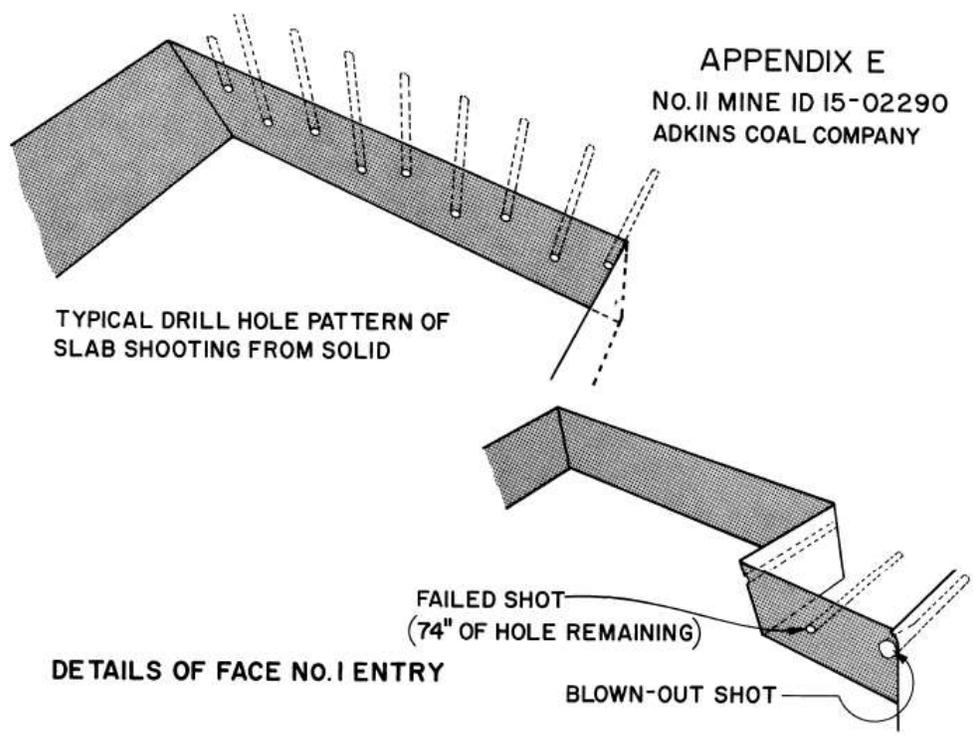
Figure 8: Blast arrangement at the Adkins No. 11 mine (Luxmore and Elam, 1982)

Root causes of the explosion were improper charging of the blast holes and inadequate suppression of the coal dust at the blasting face. Each blast hole was charged with 6 pounds of explosives. The wrappings around the explosive cartridges had been slit before being inserted, and no stemming was done. It should be noted that permissible explosives and appropriate blasting equipment had been used. However, coal dust suspended in air from the first blast was ignited by a blown-out shot from the second blast. The coal dust on the ribs, roof, and floor had not been watered or rock dusted, causing the suspension of the dust when the second blast was fired. The ventilation at the face was also ineffective in diluting and carrying away the coal dust. This event gave insight into the importance of properly controlling the coal dust and incombustible content of the dust near an active face even when there is no electrical equipment in the area.

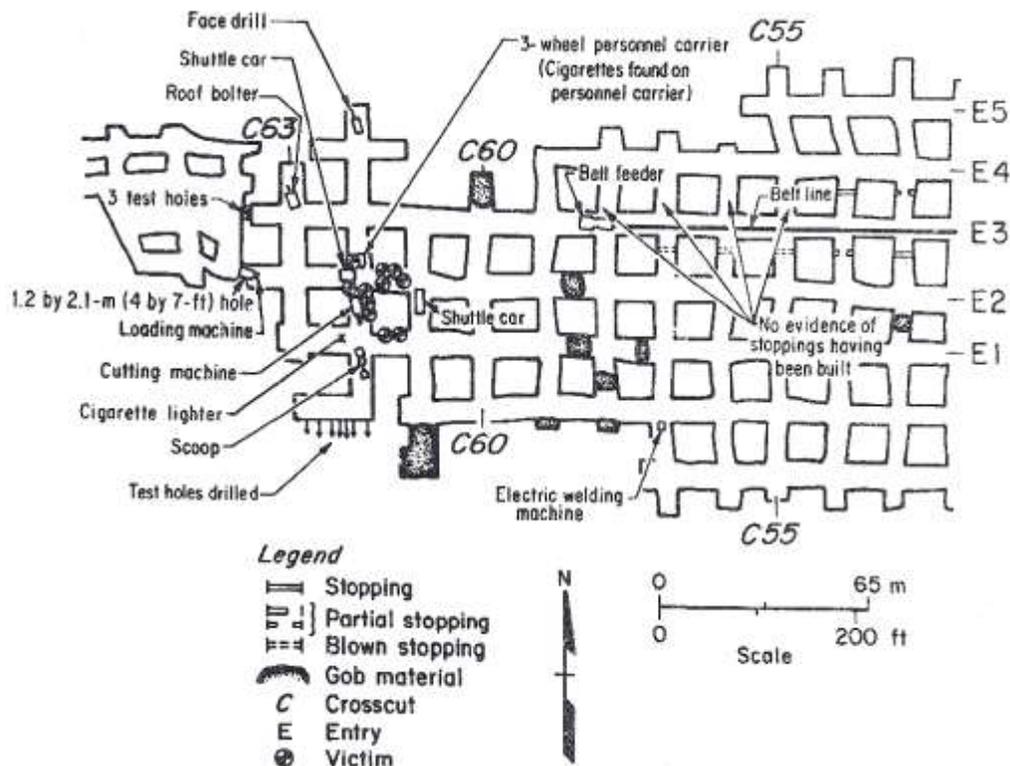
Figure 9: Explosion area of the Grundy Mining Co. No. 21 Mine (MSHA 1998).

The 003 Section was found to not have proper ventilation controls section and the the bleeder system had not been maintained for the 5 Right area where the methane had initially accumulated. Investigators suspect that methane monitoring was inadequate in the 003 section as there was no indication to the miners that an accumulation of methane had entered the section. Furthermore, the presence of a cigarette lighter indicates that there was no effective program to search for smoking articles.

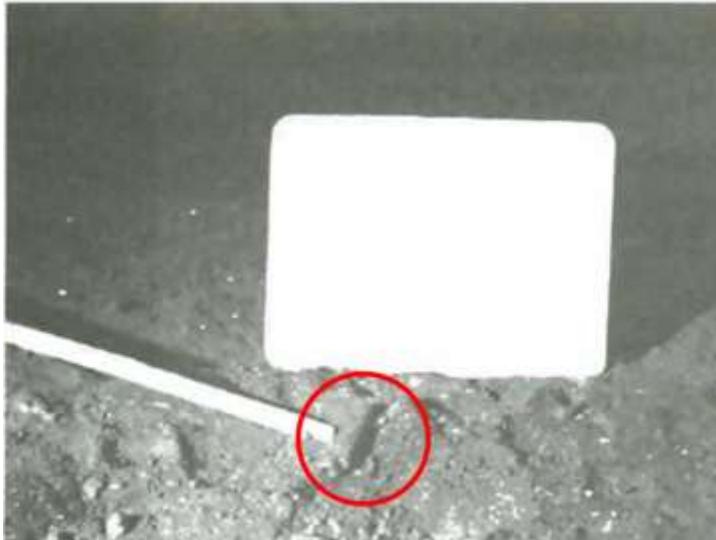
MSHA concluded that a miner using a cigarette lighter (Figure 10) had ignited the methane-air mixture. Evidence indicated that 12 of the 13 miners who perished saw the flame front just after ignition and were attempting to head outby when they were overcome by heat and toxic gases from explosion.

Figure 10: Cigarette lighter found at the explosion scene (after Holgate et al., 1982)

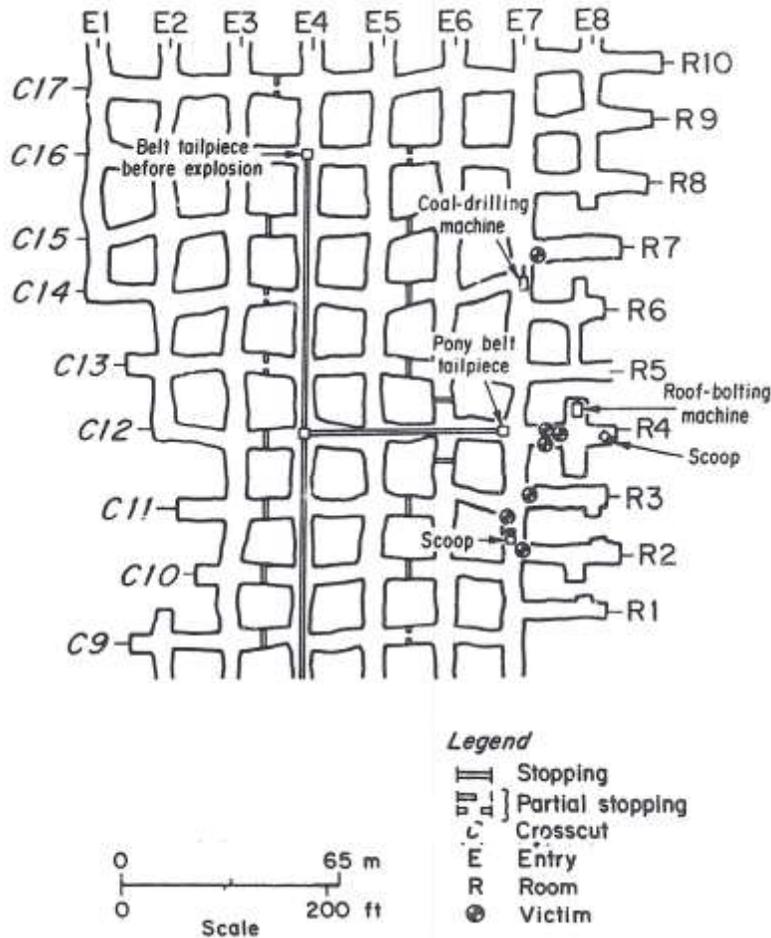
Figure 11: Explosion area at the RHF Coal Co. No. 1 Mine (MSHA 1998).

The mine operator had failed to properly apply water or other effective methods to suppress the dust within 40 ft. of the face as required by statutes. Also, insufficient rock dust had been applied to maintain the coal dust inert; instead, the operator had permitted large quantities of coal dust (including float coal dust) to accumulate along entries, rooms, and areas outby the working section.

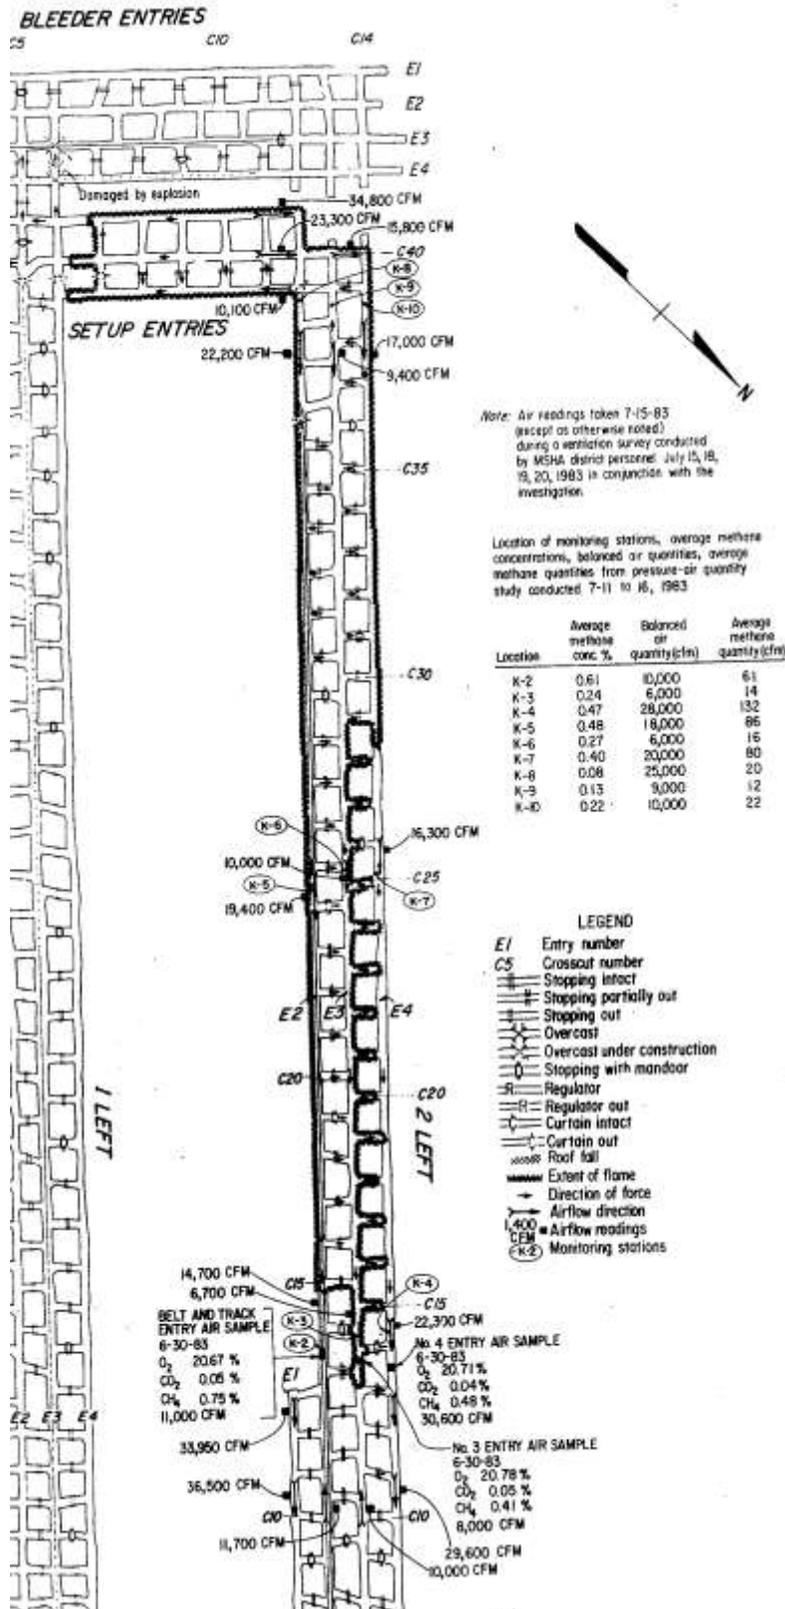
Figure 12: Partial map of the McClure No. 1 mine showing the extent of explosion damage and ventilation information. Modified after Elam et al., 1983.

Besides the failure to properly ventilate the 2 Left section following the breakthrough, the operator also failed to conduct adequate preshift and onshift examinations.

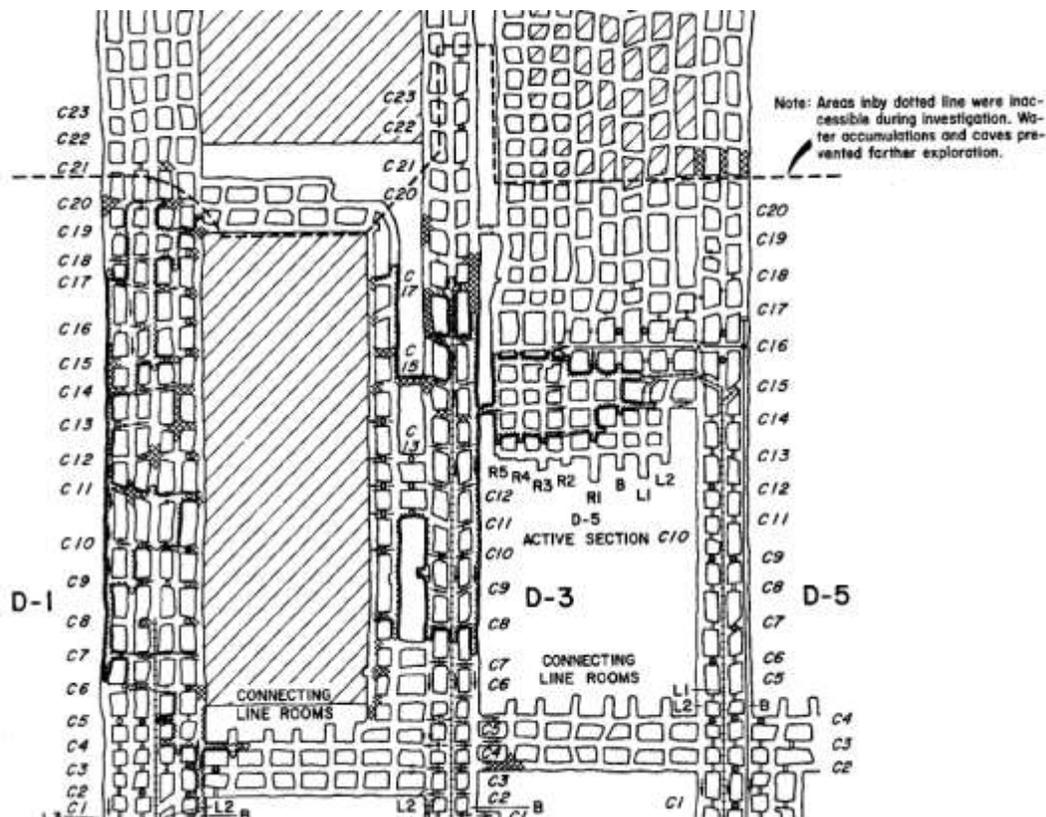
Figure 13: Map of Greenwich Collieries No. 1 Mine showing extent of explosion damage (modified from Fesak and Cavanaugh, 1984)

MSHA investigators that an accumulation of water had occurred in the D-1/D-3 longwall gob areas and bleeder entries (left side in Figure 13), restricting the air traveling inby the No. 6 crosscut in the D-3 area (marked C6 in Figure 13). The restricted airflow was inadequate to dilute or render harmless the accumulation of gases between C11 and

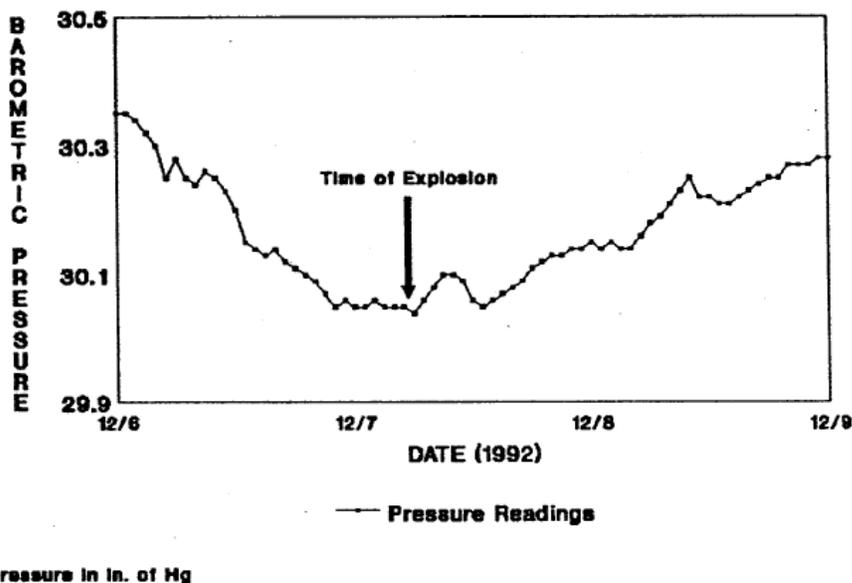
At the time of the explosion, the barometric pressure at the mine had dropped significantly within the prior 24 hours, as shown in Figure 18. As a consequence, methane may have migrated from mined-out (pillared) gobs into the active mine workings. The bleeder systems of the pillared 1 Right off 1 Left, 2 Right off 1 Left, and 1 Left sections had not been examined nor maintained to continuously move the methane air mixtures away from the active faces. The mine roof had deteriorated in the bleeder system enough to restrict the airflow and allow methane to accumulate in the pillared areas of the bleeder entry. A number of ventilation controls, both permanent and temporary, in the active working section had been removed or had not been maintained. This allowed methane to accumulate in the pillared bleeder entries and to migrate to the No. 1 entry and into the No. 2 crosscut between the No. 1 and 2 entries. The methane was ignited in the 1 Left section in the No. 2 crosscut between the No. 1 and 2 entries. A number of additional factors, such as the possibility of water, roof falls, and the dip in the coal bed, may have aided in the development of the explosion. The methane explosion resulted in sufficient forces and flames to suspend and ignite coal dust in 1 Left which continued to propagate the entire distance of the No. 1 West Main entries to the surface area of the mine.

Figure 18: Barometric drop prior to the Southmountain mine explosion (Thompson et al., 1993)

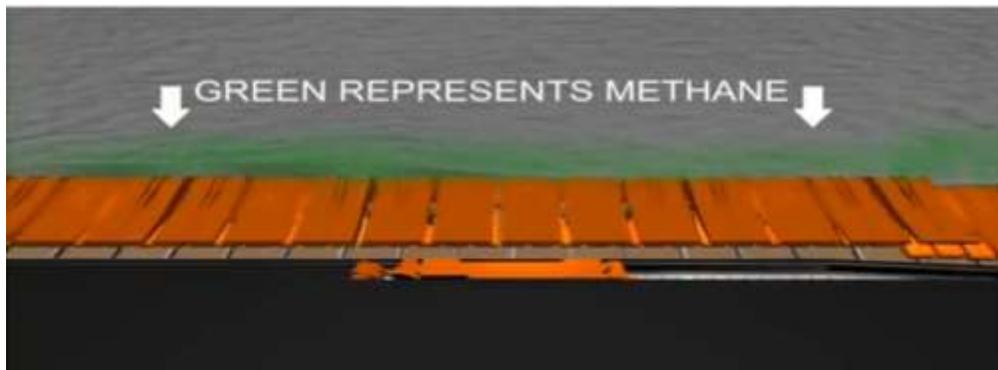
In a video presented by MSHA (2011) that simulated the likely scenario of the UBB explosion, MSHA showed an accumulation of methane along the fringe of the gob behind the longwall shields. Figure 27 shows a snapshot from this video, with the green shading representing the explosive methane fringe zone in the gob behind the shields.

Figure 27: Depiction of methane explosive fringe in the longwall gob behind the shields at the Upper Big Branch mine. Not to scale. (MSHA, 2011)

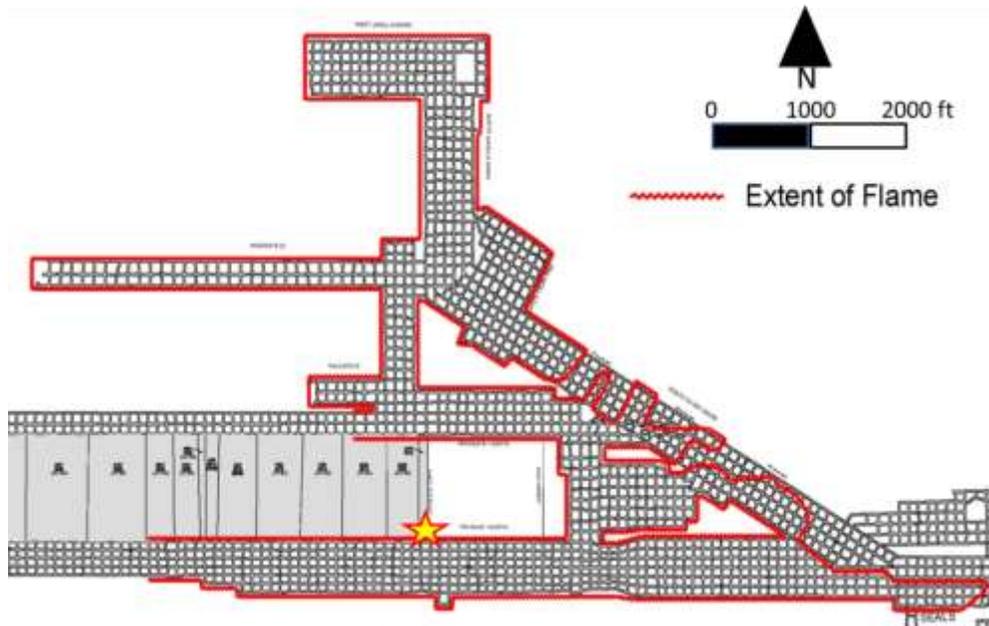
Figure 28: Extent of the flame zone of the Upper Big Branch mine explosion. The star indicates the origin of the explosion on the tailgate side of the longwall face. Modified after Page (2011).
