# Lessons Learned from Mine Disasters: New Technologies and Guidelines to Prevent Mine Disasters and Improve Safety

By Jürgen F. Brune and Benjamin Goertz

## A Research Report

Colorado School of Mines, Mining Engineering Department

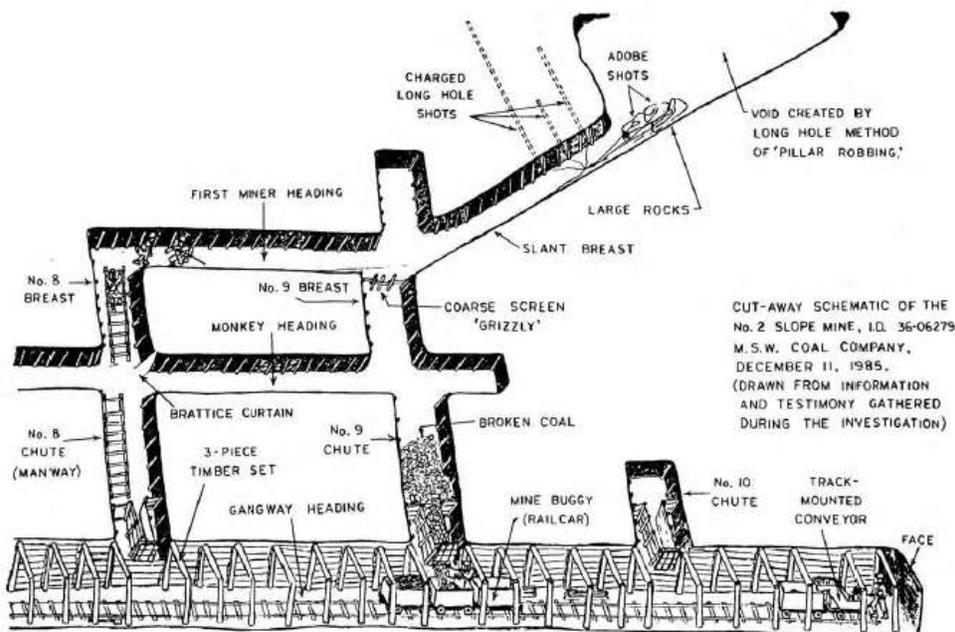
Figure 14: Sketch of the M.S.W. Coal No. 2 Slope Mine (Glusko et al., 1986)

MSHA investigators determined that the volume and velocity of the air required to ventilate the slant had been insufficient to dilute and carry away the methane being liberated around the void. The accumulation of methane in the slant led to an explosive air mixture that was ignited by the detonation of the explosives in the slant. The proximity of the miners to the blasting and explosion zone also played a factor in their deaths. In addition to the ventilation issues, the miners loading and detonating the shots did not measure the methane concentration or the air quantity before or during work activities or blasting.

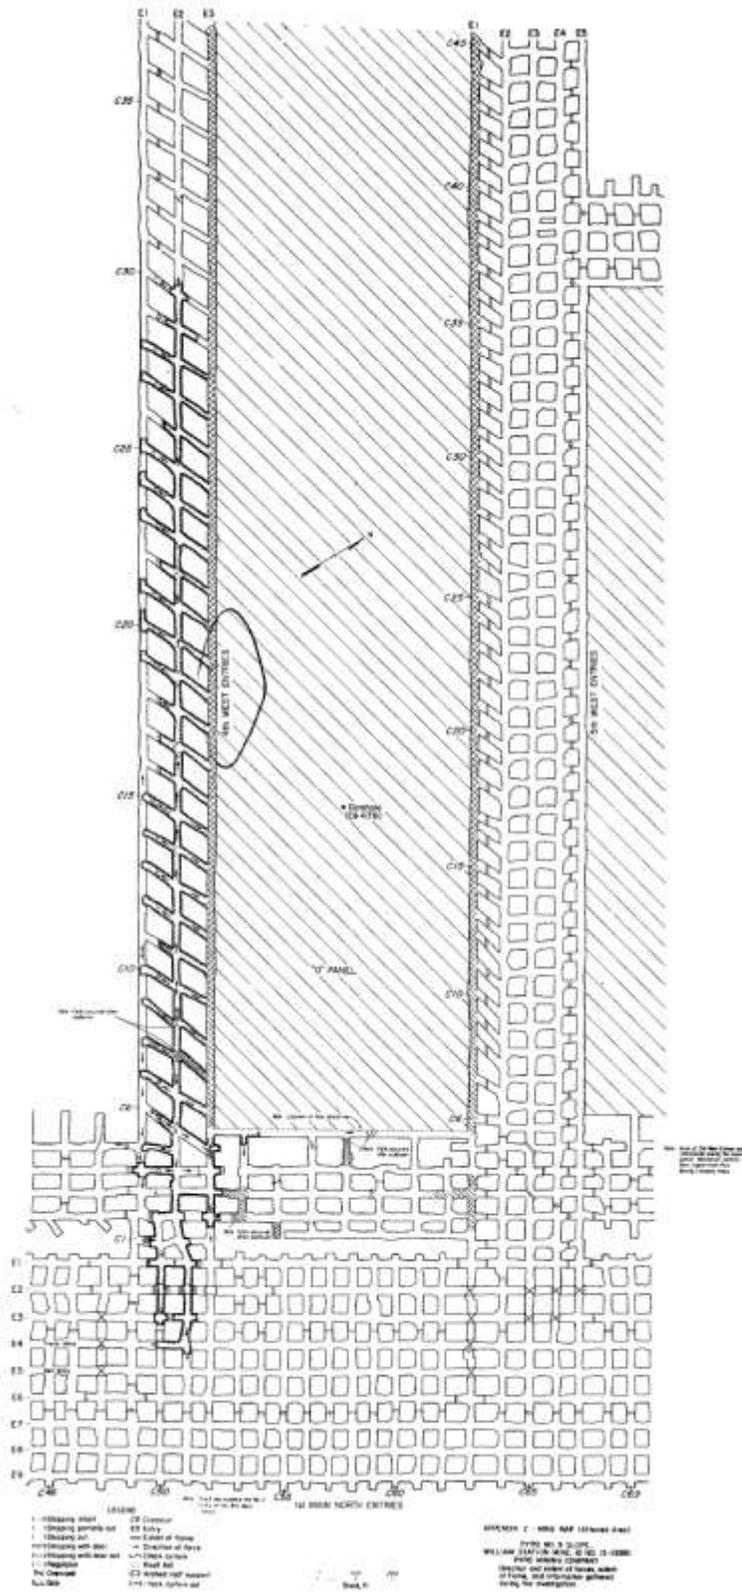
Mine operators failed to recognize the sensitivity of the bleeder ventilation system and the impact the ventilation changes would have. In addition, temporary stoppings had not been maintained in the 4<sup>th</sup> West entries where permanent stoppings had been removed. A preshift examination had not been conducted in the Longwall Panel "O" recovery area earlier in the day. Additionally, on September 9<sup>th</sup>, corrective actions were not taken when an explosive methane concentration had been detected along the longwall face.

Figure 15: Map of Pyro No. 9 Slope Mine showing the extent of the explosion (Childers et al., 1990)

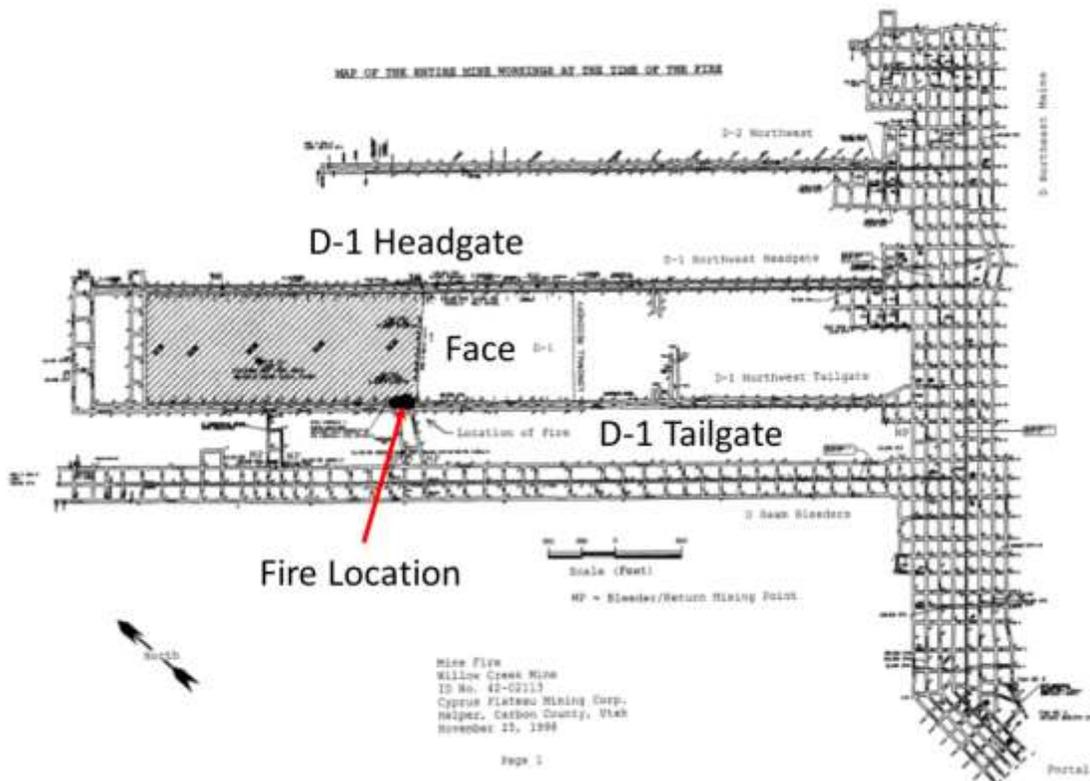
Figure 19: Map showing the location of the 1998 Willow Creek explosion and fire (Elkins, 2001)

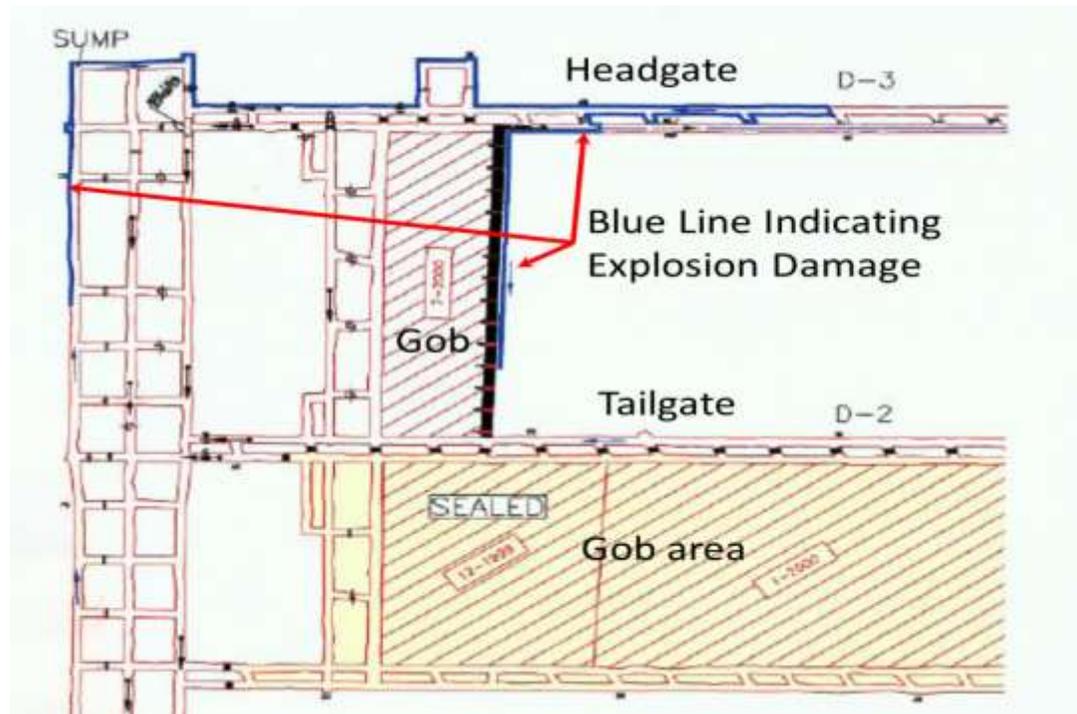
Figure 20 shows an excerpt from the mine map depicting the area affected by the explosion as a blue line beginning on the face near the tailgate, wrapping around the headgate and extending into the bleeder system.

Figure 20: Map of the Willow Creek Mine, 2000 explosion (After McKinney, 2001, no scale indicated)

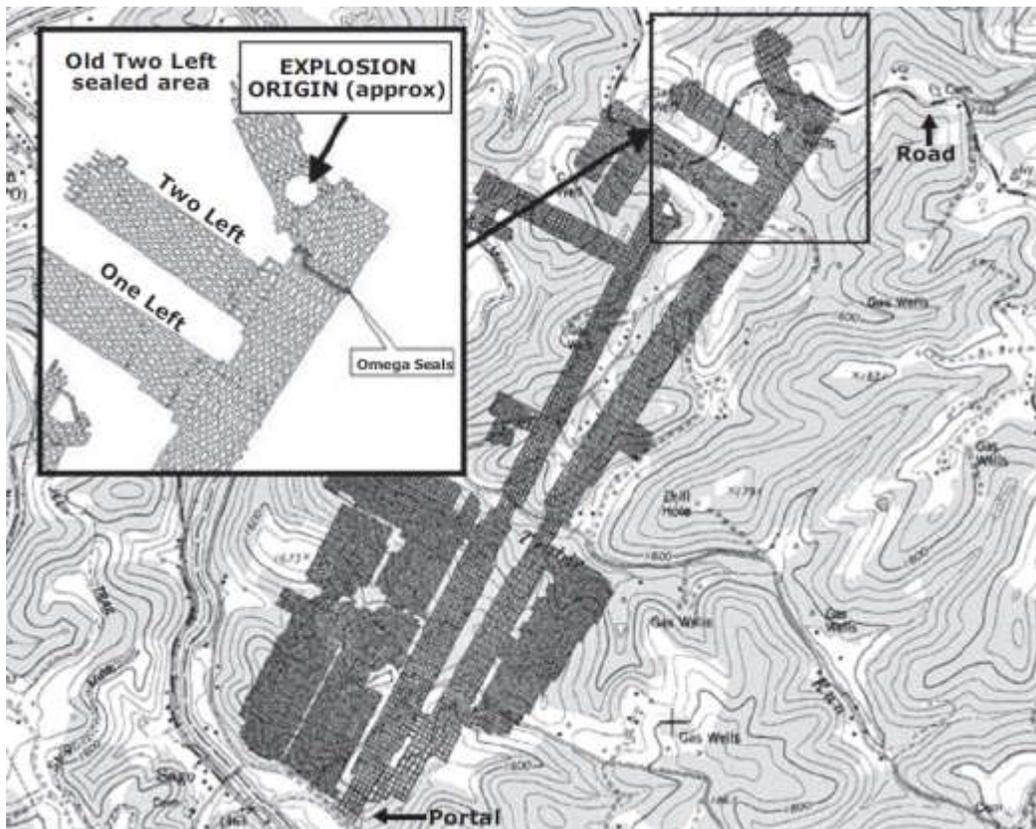
Figure 22: Map of Sago Mine (McAteer 2006), showing the location of No. 2 Section and the origin of the explosion.

On January 2<sup>nd</sup>, 2006 an explosion occurred in by the 2 North Mains seals labeled Omega seals in Figure 22) and destroyed all ten of the seals used to separate the abandoned area from the active portion of the mine. The miners underground felt the concussion of the explosion which entrained a large amount of dust into the air causing poor visibility for a number of miners that ranged from 10-15 feet to 8-10 inches visibility. Some miners donned SCSR units and began to exit the mine.

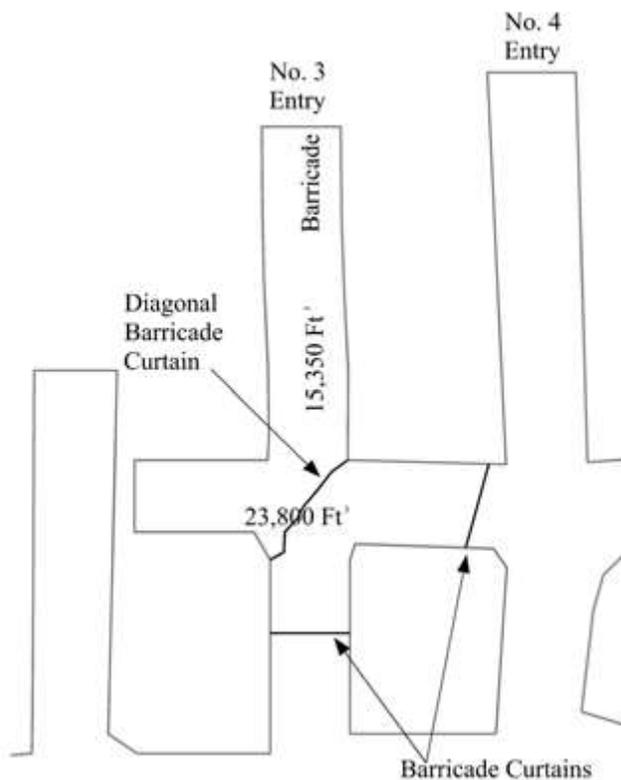
Figure 23: Drawing of Barricade (Gates et al., 2006).

It is unknown what the CO concentration was at the time the barricade was constructed but issues with barricade construction are believed to be the leading cause of its failure. The curtain across the crosscut between No. 3 and 4 entries was loosely hung and open about a foot on the inby side. The diagonal curtain that was hung was left open about a foot on each side and no material was found on the bottom of the curtain that would have acted as a sealing material to create a tight fit. MSHA noted that a number of locations around the crew had possible barricading materials such as pallets of 6-inch concrete blocks, mortar, wedges, headers, cap boards, 8-foot posts and spray sealant. The situation that the miners were in may have left them rushed and panicked making them think they needed to put up a barrier as quickly as possible even if it meant it was of subpar construction.

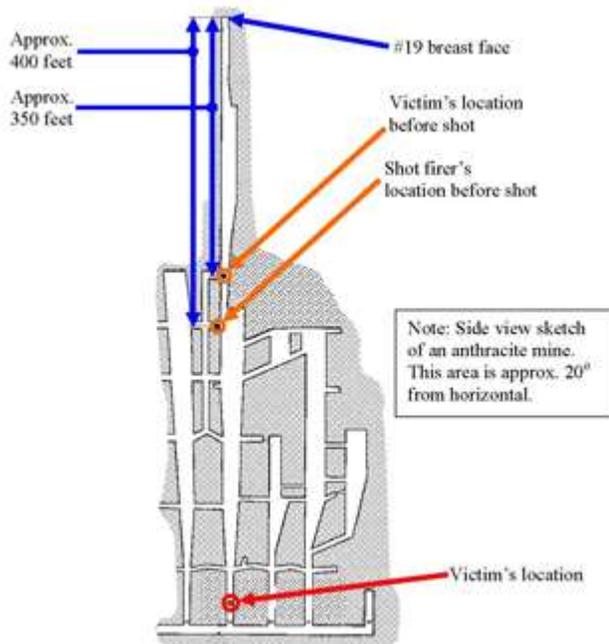
Figure 25: Map of the R&D Coal Company Mine (Garcia et al., 2007)

At approximately 6:50 a.m. on October 23<sup>rd</sup> a preshift examination was concluded at the mine. Records from the examination indicate that the face of the No. 19 Breast had not been preshifted during this examination. The production shift commenced shortly after and blasting preparations began in the No. 19 Breast. After blast holes were drilled and loaded, a check for methane found there was none in the area. Upon blasting, two expected blasts were heard but a third blast with concussive force indicated that to the outby miner that something was wrong. Excessive smoke rapidly filled the area following the blast and the miner closest to the blast was found fatally injured.

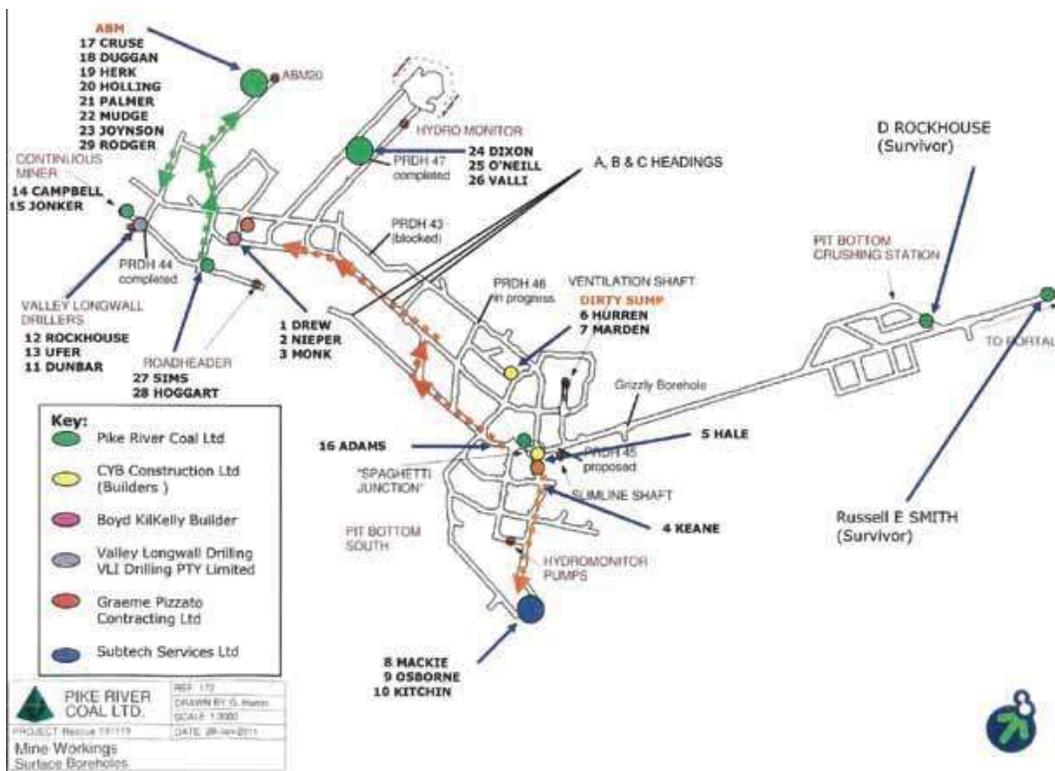
Figure 26: Last known position of the 29 deceased and two survivors (RCPRCMT, 2012).

The mine was new and the owner had not completed the systems and infrastructure necessary to safely produce coal in addition to its health and safety systems being inadequate. Pike's ventilation and methane drainage systems were inadequate. There were numerous warnings of a potential catastrophe at Pike River. In the last 48 days before the explosion there were 21 reports of methane levels reaching explosive volumes, and 27 reports of lesser, but potentially dangerous, volumes. The reports of excess methane continued up to the very morning of the explosion.

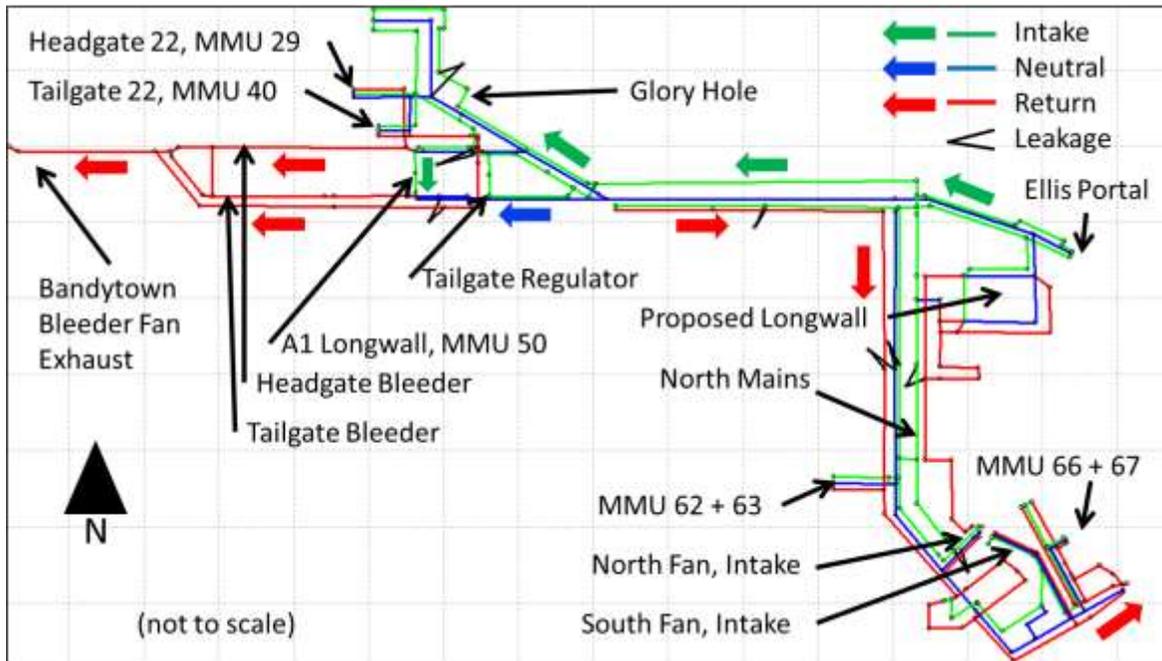
Figure 30: Overview of the UBB ventilation schematic representing. Airway purposes are indicated by line color. MMU stands for “mechanized mining unit” and denotes the active working sections.

The UBB longwall is ventilated in an “H” pattern with fresh air feeding to the face on the headgate and neutral air coursing to the face from the tailgate. If the tailgate airflow were cut off to zero, air reversal would be expected to occur in tailgate entry No. 7 just outby the face. This (see Figure 30) happens because the No. 7 entry inby the face is partially blocked by the caving of the gob, causing some of the air from the face to seek an alternate path to the Bandytown bleeder fan via leakage along the stopping lines between entries No. 6 and 7 as well as No. 2 and 3. The tailgate air reversal is contingent upon and depending on this leakage; without it, reversal would not be possible.

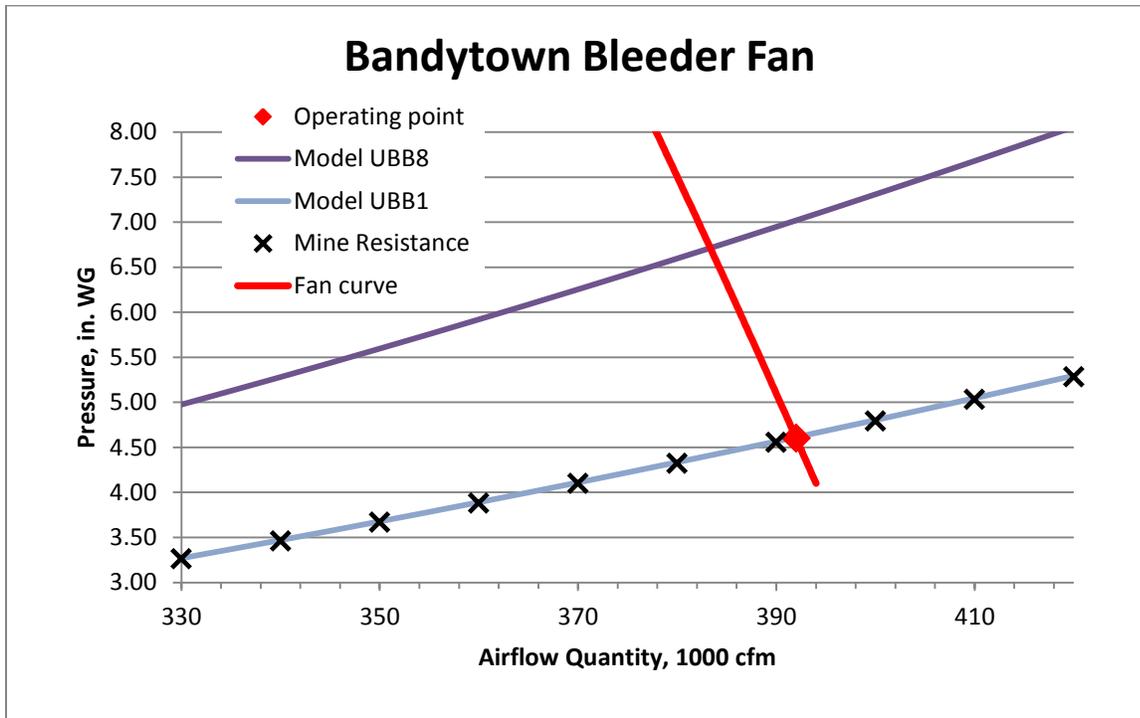
significantly higher while in the base model, the resistance and operating point match closely with the measured value of 397,100 cfm at 4.6 inches WG; therefore, the above  $R_{1000}$  values are good choices. Note though that these resistances are still greater (by a factor of 2 or more) than those values used by UBB personnel.

It should be pointed out that, even if the actual mine resistance was significantly higher, the corresponding quantity would not drop very much because the fan curve is quite steep near the bottom end of the fan's operating range. Conversely, a small change in fan quantity will result in a much larger change in operating pressure.

Figure 31: Mine resistance curves and fan characteristics for the North fan

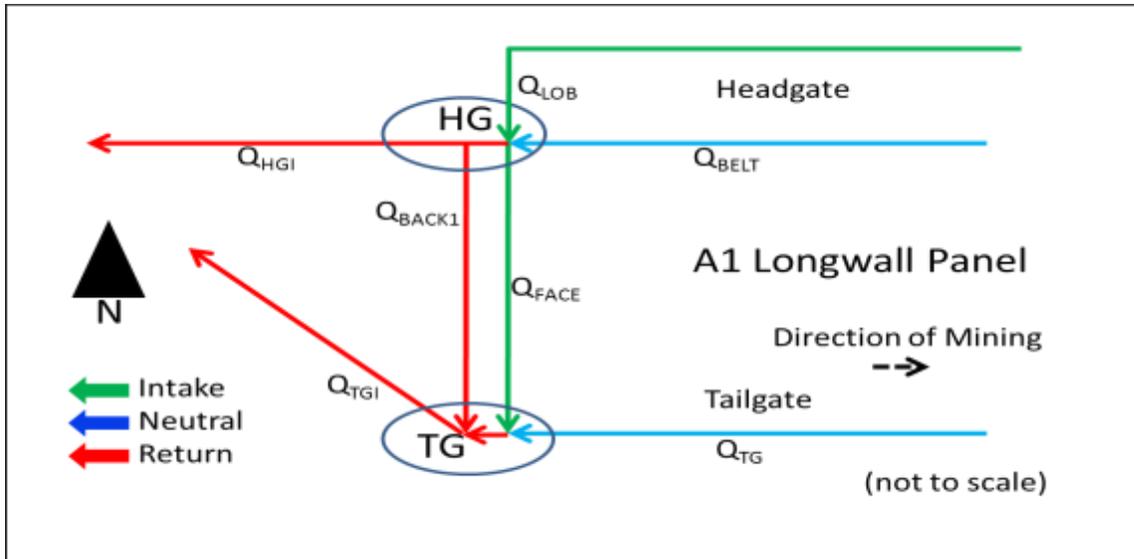
Figure 33 shows the corresponding line diagram. The longwall is ventilated in an “H” pattern with fresh air directed towards the tailgate from the mains to the face ( $Q_{TG}$  flowing right to left in Figure 33).

The ventilation plan document does not show an air quantity on the longwall face itself. However, this quantity can be back calculated from the airflow balance at the tailgate. According to Kirchhoff's law, this balance at junction TG (oval, see Figure 33) yields the following:

Figure 33: Airflow balances at longwall startup, with airflow directions showing an “H” ventilation pattern.

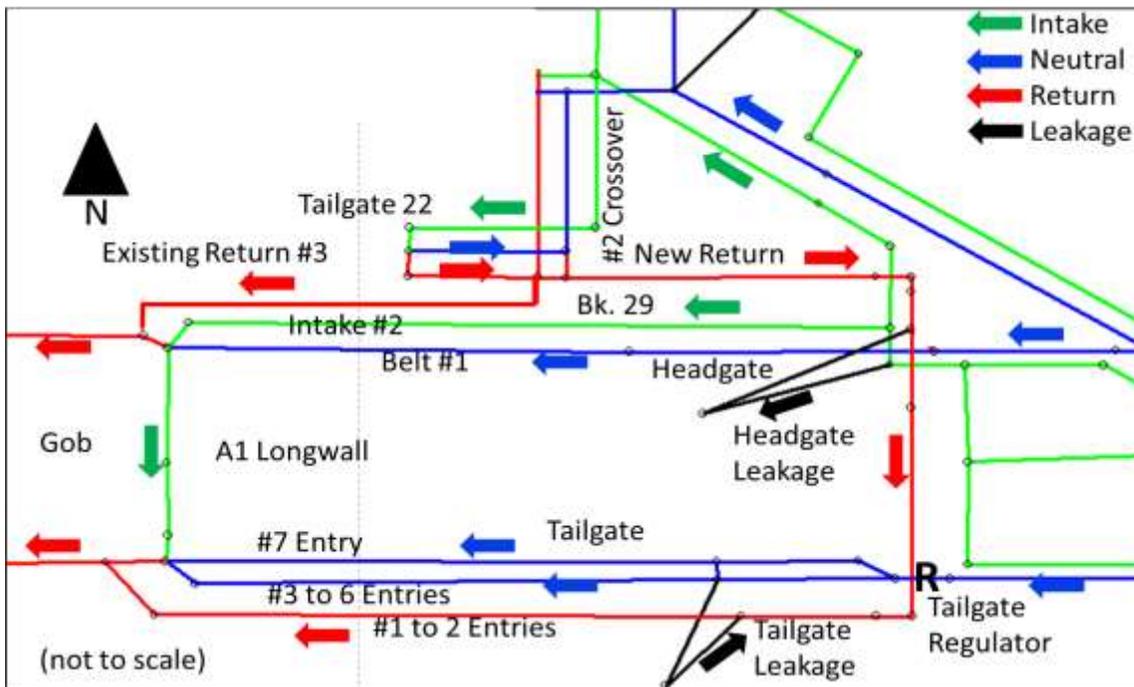
With revision B6-A13, major air changes on the longwall were approved on 12-18-2009. With this revision, UBB proposed to no longer use the No. 3 entry in the longwall headgate as a return entry for the CM development (MMU 40, cutting tailgate development TG 22) and instead convert it to an intake. Figure 34 shows this route labeled "Existing Return No. 3". Note that, at this time, the longwall belt was ventilating towards the face.

Figure 34: Routing of belt air and Tailgate 22 development return

The existing return used the No. 3 entry of the headgate to send the return air from the CM development directly to the bleeder fan, which was a ventilation method preferred by Massey-UBB (Massey Energy, 2010). Instead, in this ventilation plan revision, the mine operator proposed to route a new return to the bleeder fan via the mains and entries No. 1 and No. 2 in the tailgate (shown in Figure 34 as “New Return”).

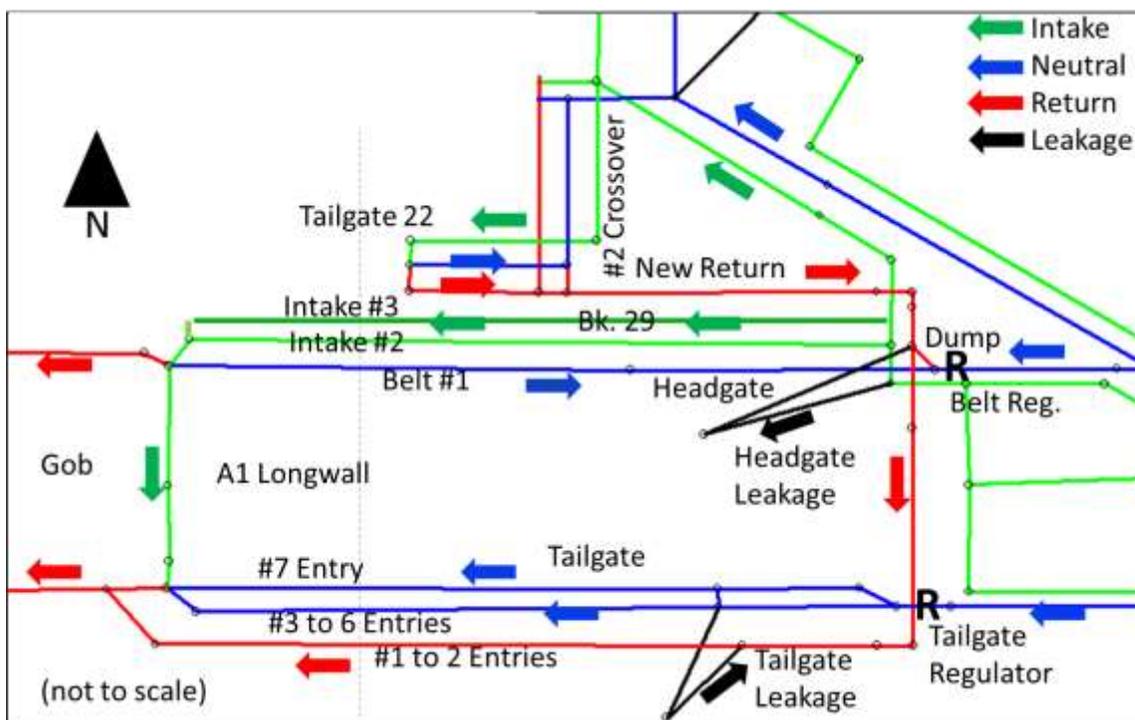
supply more fresh air to the face, as shown in Figure 35. This permitted UBB to reverse the longwall belt air to an outby direction (shown in Figure 35), as proposed by UBB and MSHA-approved in the same ventilation plan revision B6-A13 (12-18-2009). In order to reverse the belt air, UBB had to establish a belt dump regulator at the neck of the longwall headgate where the belt air is fed to the mains return and out the tailgate.

A model variant was generated from the base model to represent the longwall status in late December 2009 based this revision. Modeling shows that, in the entry configuration of December 2009 (plan revision approved on 12-18-2009), it would have been difficult to direct the belt air away from the longwall face while maintaining sufficient air quantities on all belts, to the newly necked-off HG22 development section, and the longwall. One key problem is that UBB tried to feed the belt air from the HG 22 section to the longwall belt as there was no suitable alternative route for this belt air.

Figure 35: Adding longwall intake No. 3 and intended routing of belt air outby

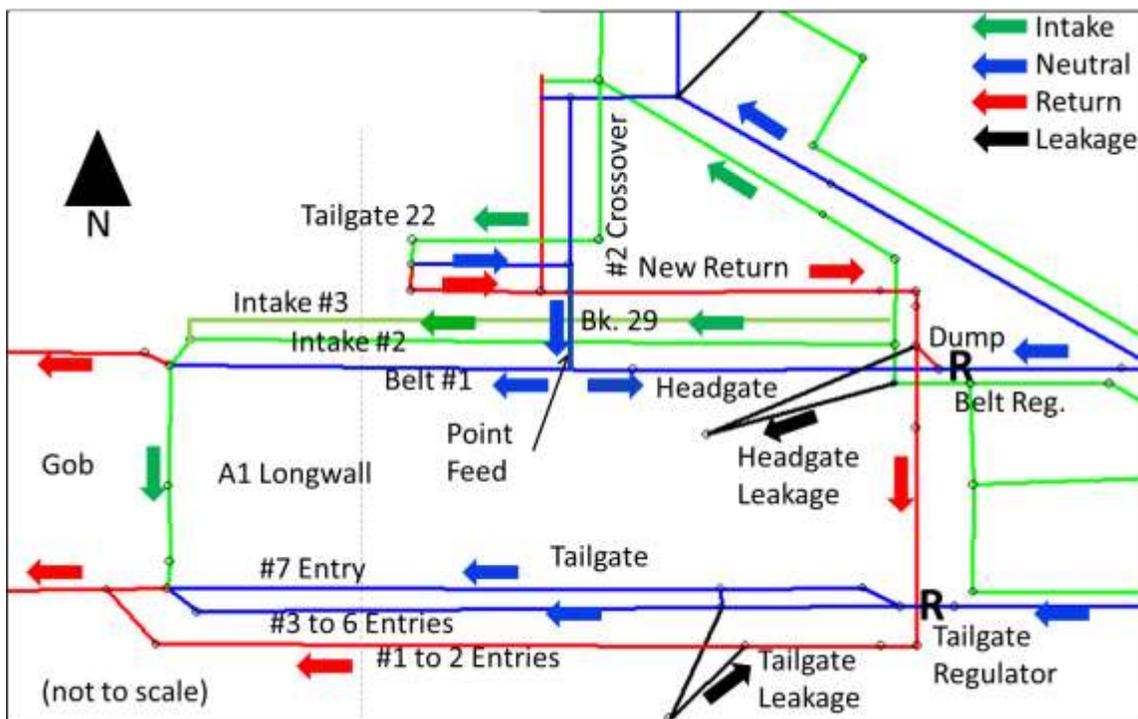
With the revision B6-A15, approved on 01-22-2010, UBB proposed to again use the “Intake No. 3” (Figure 36) entry as an alternative return for the northern CM development sections once the longwall face had passed the No. 2 crossover mains. Modeling shows that re-opening the headgate return would have had no significant impact on the longwall but would have improved air quantities in the northern CM development sections due to the added return capacity. It should be noted that the A1 longwall belt air continued to flow away from the face from that time on, as approved in the ventilation plan.

In late March 2010, after passing the No. 2 Crossover (Bk. 29, see Figure 36) and eliminating the point feed, the belt air flowed away from the face entirely. This change in belt ventilation was proposed in revision B6-A26, approved on 03-22-2010. Although part of the headgate had to carry return air from the northern CM development sections, at this time the longwall intake would have had two full entries available for intake air in that the headgate was widened to 5 entries outby the No. 2 crossover.

Figure 36: Schematic view showing the major return air change made with revision B6-A13, approved on 12-18-2009.

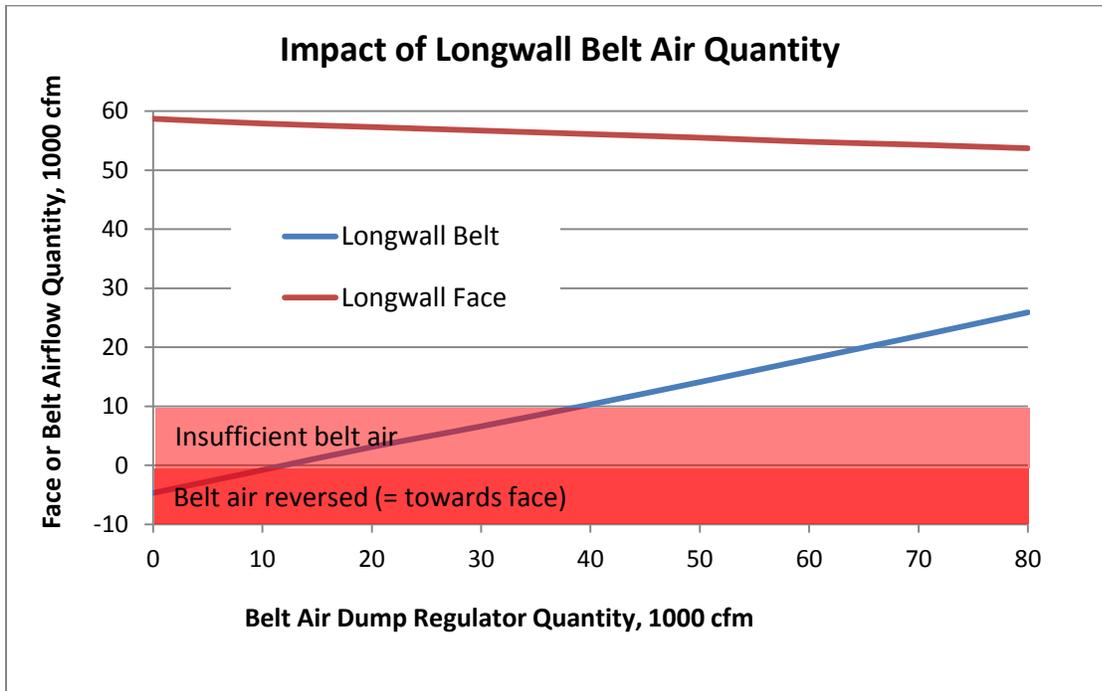
Ventilation modeling has demonstrated that the longwall face air quantity is largely unaffected by these belt air changes, since the face air quantity is primarily governed by the resistances on the return and bleeder side and the power of the Bandytown bleeder fan. This can be easily demonstrated by varying the belt air quantity. Figure 37 shows

By varying the belt dump regulator (see Figure 36) in the model, the belt airflow can be regulated. Fully closing the belt dump results in a reversal of belt airflow while generating only a slight increase in longwall face airflow of 58,700 cfm compared to 56,000 cfm in the base model. By opening the regulator to 80,000 cfm, about 26,000 cfm of belt air can be drawn from the face into the dump point. This would slightly reduce the longwall face quantity from 56,000 cfm to about 53,000 cfm.

Figure 37: Impact of longwall belt airflow and direction.

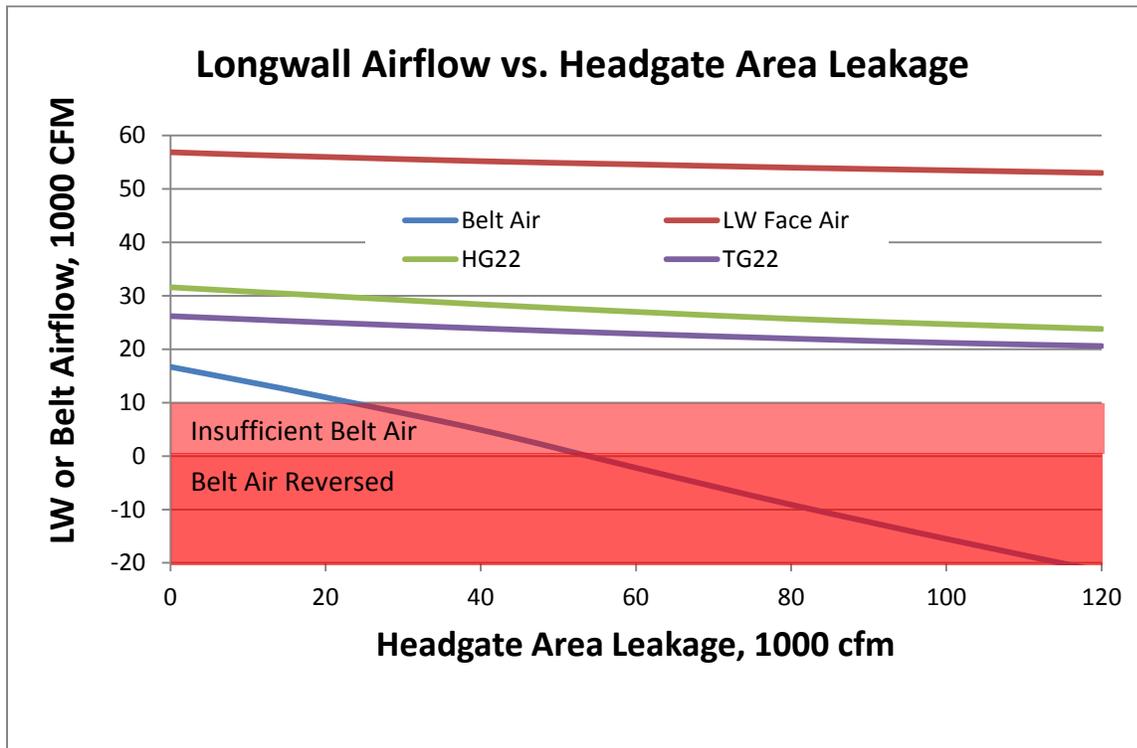
Figure 38 shows the changes in longwall belt, longwall face and development section LOB airflow as a function of leakage between intake and return entries along the longwall headgate and the mains. This leakage occurs from the intake to the return along the longwall headgate (16 stoppings, 2 overcasts) and along the A1 crossover mains (13 stoppings). The base model assumes about 20,000 cfm of leakage in this area.

Modeling (Figure 38) shows that the longwall and development face air quantities are affected by this leakage. Since the graphs have similar slopes, the relative impact is felt less at the longwall face (8% change over the range of leakage flows) while the relative impact on the air available to ventilate the two northern development sections is greater (33% for HG 22 and 28% for TG 22). The longwall belt air quantity drops significantly and eventually reverses as the leakage is increased above 53,000 cfm. Under these conditions, it is also expected that the return air flowing in the No. 4 and 5 entries of the longwall headgate (“New Return” in Figure 36) will reverse. Significantly high leakages

in the longwall headgate area can occur from damaged stoppings, overcasts and other ventilation controls. Such leakage or short circuiting of air might also happen if both double doors separating the No. 3 (intake) and No. 4 (return) entries at in the longwall headgate, crosscut No. 28, are left open.

This simulation shows that it is critical to control the leakage in the headgate area to provide adequate ventilation of the longwall belt and the northern development sections.

Figure 38: Longwall, development face and belt airflow vs. headgate area leakage.

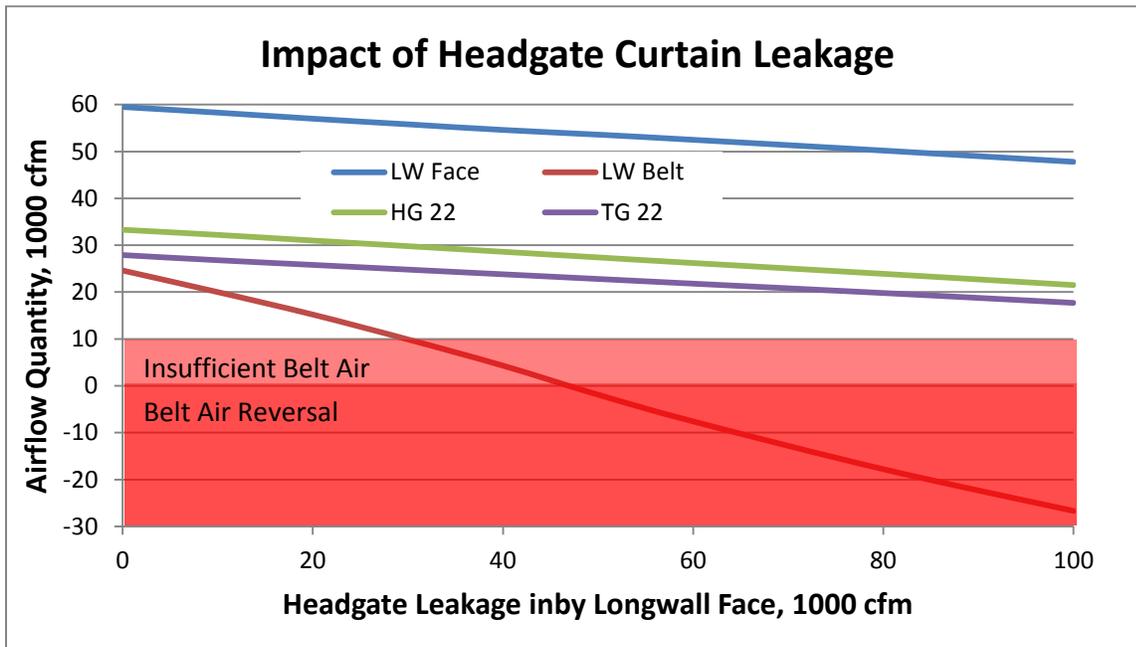
Figure 39 shows the changes in longwall face and belt airflow as a function of leakage from the longwall headgate towards the bleeders.

The base model assumes about 28,000 cfm of leakage in this area. The UBB mine ventilation plan does not provide any information about this leakage, but MSHA provided air velocity data from a call-out made on April 5, 2010 just prior to the explosion<sup>9</sup>. A velocity of 700 fpm (equivalent to 56,000 cfm) had been measured on the longwall face near the headgate while 513 fpm (equivalent to 41,000 cfm) had been recorded near the tailgate. This indicates that about 27% of the face quantity is lost in

Figure 39 shows that, if headgate curtain leakage had increased above 30,000 cfm, the belt airflow would drop below 10,000 cfm and might no longer be sufficient to dilute methane below statutory limits. If the leakage increased above 47,000 cfm, the belt air would reverse. Such high leakages might be caused if one or more of the check curtains in the headgate were torn down, for example, as a result of a roof fall. Such belt air decreases and eventual reversals caused by excessive headgate curtain leakage are typical for all longwalls that ventilate belt air away from the face.

Figure 39: Effect of longwall headgate leakage on face and belt airflow.

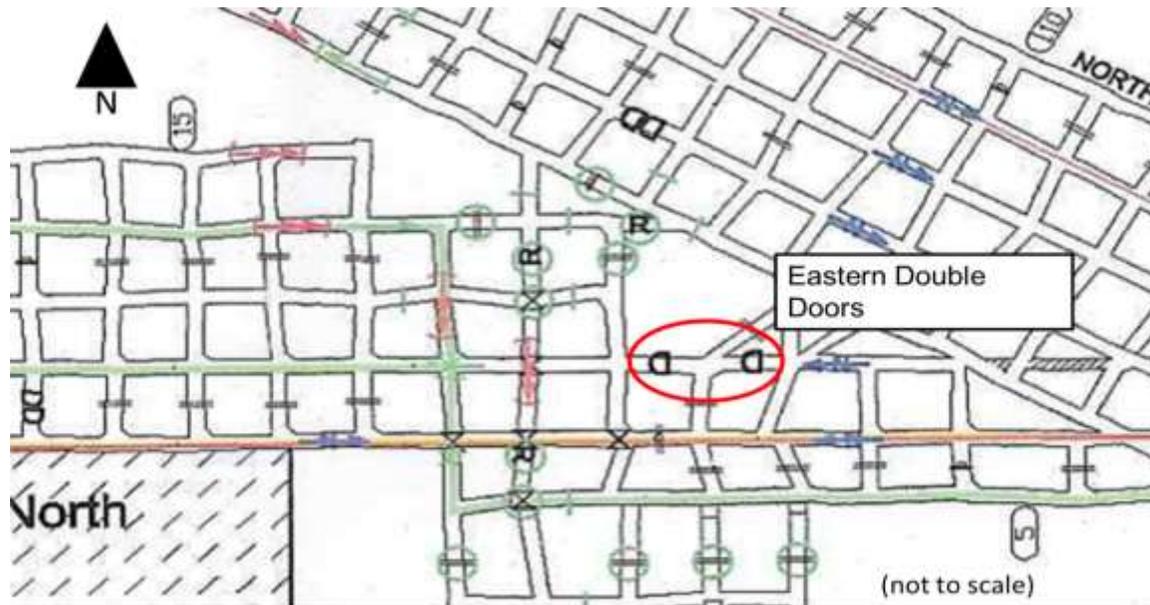
The base ventilation model uses the stopping, regulator, and double door configuration outby the longwall headgate as shown in Figure 40 taken from Ventilation Plan Revision B6-A17, approved on 02-16-2010.

If the double doors were both opened at the same time, the base model shows that several major airflow changes would be expected to occur, as shown in Table 4:

- The longwall belt air would reverse. In addition, the return air from the development sections to the mains would also reverse.
- The airflow at the longwall face would remain largely unchanged while slightly less air would flow to the northern development sections (HG 22 and TG 22).
- When both doors are open, they would form a direct connection for intake air to flow to the neutral and belt airways; in addition, the longwall intake escapeway would no longer be isolated.

Figure 40: Location of double doors, ventilation plan revision B6-A17, approved on 02-16-2010.

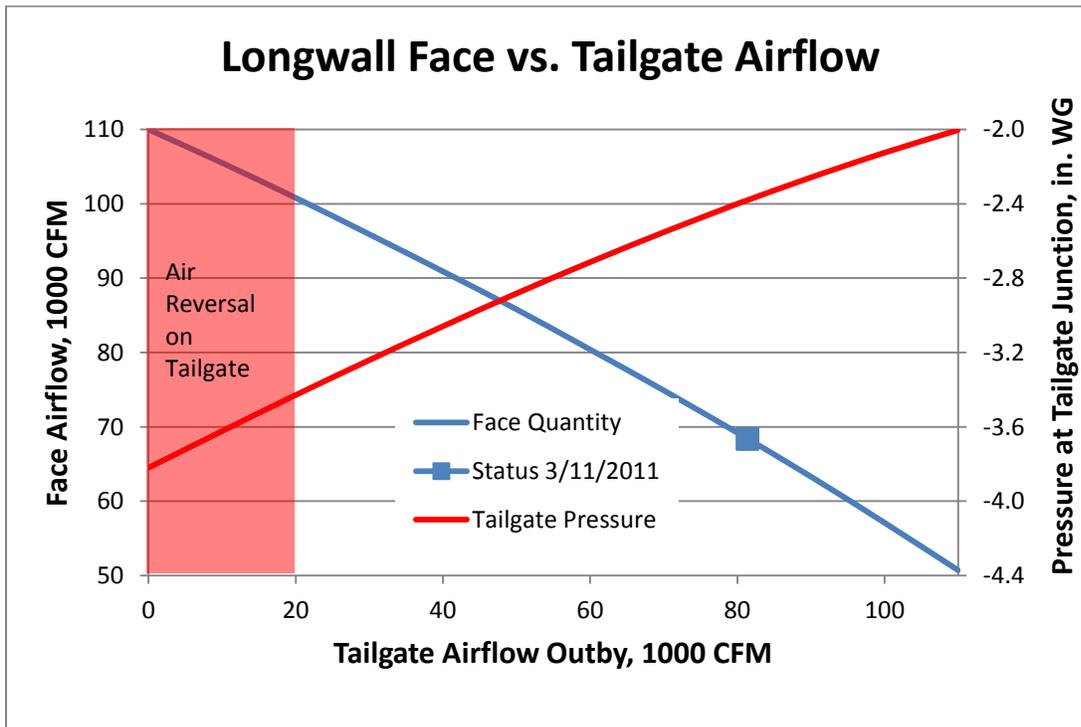
In order to provide a fresh air escapeway in the tailgate, the UBB mine must feed neutral air up the tailgate from the mains to the face through the tailgate regulator (see Figure 36). In the ventilation plan revision B6-A25, approved on 03-11-2010, the total air quantity directed to the face was reported by UBB as about 74,000 cfm. Figure 41 shows the amount of longwall face air quantity as a function of the tailgate regulator neutral air quantity, along with the absolute pressures at the tailgate junction.

Figure 41: Longwall face air quantity as a function of tailgate airflow on 3-11-2010

The ventilation model shows that decreasing the tailgate airflow will increase the longwall face quantity. This is a common observation in longwall ventilation and has been described by Brune et al. (1999). In this case, since there is leakage from the tailgate neutral entries (No. 3 to No. 6) to the tailgate return entries (No. 1 and No. 2), an additional effect occurs: If the tailgate neutral airflow were reduced below about 20,000 cfm, the airflow in tailgate entries No. 3 to No. 6 would reverse (red area in Figure 41) while the longwall face quantity would continue to increase. If the tailgate airflow were cut off to almost zero, air reversal would also be expected to occur in entry No. 7, as discussed earlier.

The red line in Figure 41 depicts the absolute pressure at the longwall tailgate junction. It shows that, by closing the tailgate regulator and reducing the air quantity in the tailgate, the negative air pressure at the tailgate would be substantially increased (i.e., to a more negative value). Closing the regulator completely would not only cause a reversal of the airflow in the tailgate but would also drop the absolute pressure at the tailgate junction by about 1.4 inches water gauge (from -2.4 inches at the assumed operating point to -3.8 inches, see Figure 41). This is equivalent to a 0.1-inches Hg atmospheric pressure drop and could cause methane from the gob to migrate into the tailgate entries. If this drop in pressure happened rapidly (by closing the regulator on the longwall tailgate) it could result in a sudden expansion of methane from the longwall gob into the active mine workings around the tailgate area.

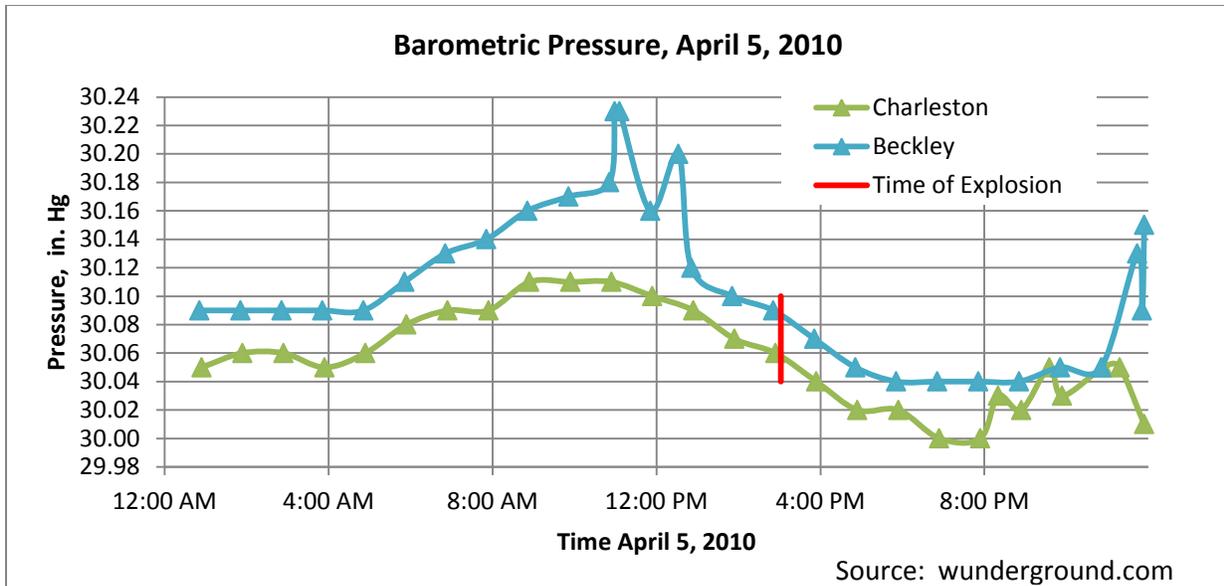
Figure 42 shows that, at the time of the explosion, about 3:02 p.m. on April 5, 2010, the barometer (Weather Underground, 2010) at Charleston WV had dropped by about 0.055 inches Hg from its high around 10 a.m. that morning. The drop in Beckley, WV was even more pronounced – a steep drop of about 0.11 inches Hg from a high around 1 pm. This atmospheric pressure drop is of about the same magnitude as the pressure drop would have been from suddenly closing the tailgate regulator.

Figure 42: Barometric pressure in Charleston and Beckley, WV, on April 5, 2010 (source: [www.wunderground.com](http://www.wunderground.com))

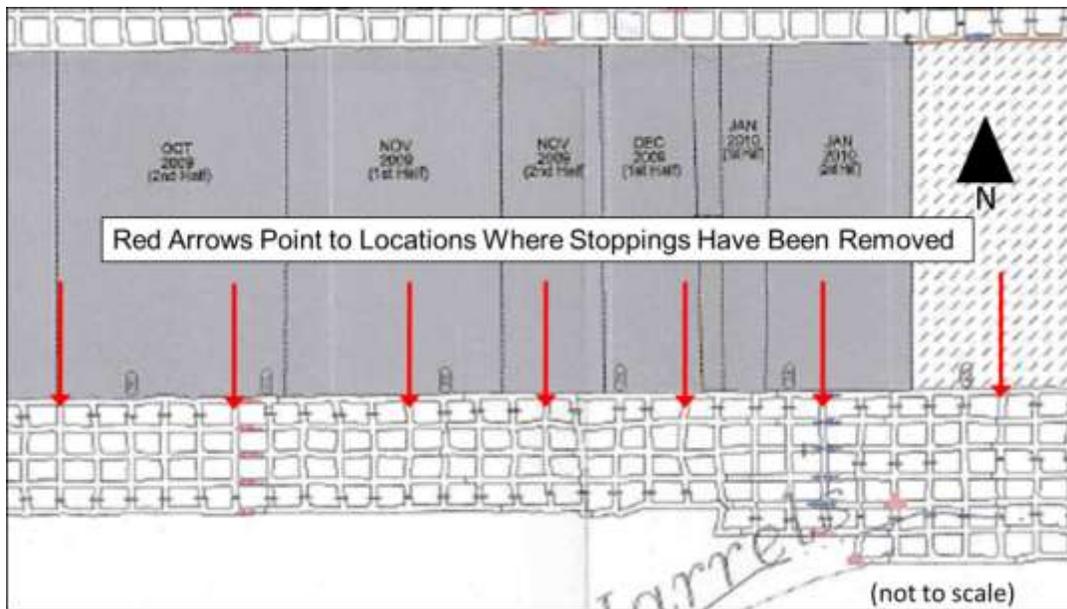
Figure 43 shows the pattern of stopping removal between the No. 6 and No. 7 entries in the longwall tailgate, per the UBB Ventilation Plan Revision B6-A17, approved on 02-16-2010. This map shows that UBB removed only every 4<sup>th</sup> or 5<sup>th</sup> stopping (as indicated by the red arrows), while the other stoppings are shown as having remained intact inby the face. It is unknown why UBB chose such a stopping removal pattern. In contrast, it is interesting to note that the approved ventilation map showing the “typical longwall face ventilation” per the UBB Base Ventilation Plan and Annual Map - Part 1 - approved on 9-11-2009 (Figure 44) does not show any intact stoppings inby the tailgate

The major problem that might be caused by leaving the tailgate stoppings intact inby the face would restrict tailgate air from flowing from the No. 7 entry to the No. 6, 5, 4 and 3 entries. Typically, the No. 7 entry caves tightly shortly inby the face. Leaving the stoppings in could cause a restriction on the tailgate that might severely reduce the face quantity.

In addition, such a restriction could cause an air reversal in the No. 7 tailgate entry outby the longwall face. This reversal could carry return air from the face for several hundred feet outby and could contaminate the outby area of the tailgate with float coal dust as well as methane. In fact, the base model shows this ventilation configuration might create a negative pressure gradient that could pull methane- and dust-contaminated air from inside the gob area out to the tailgate entries where miners work and travel. This was also noted by the MSHA inspector who cited the air reversal on the tailgate on March 9, 2010<sup>11</sup>.

Figure 43: Pattern of tailgate stopping removal at UBB, Ventilation Plan Revision B6-A17, approved on 02-16-2010 [red arrows added].

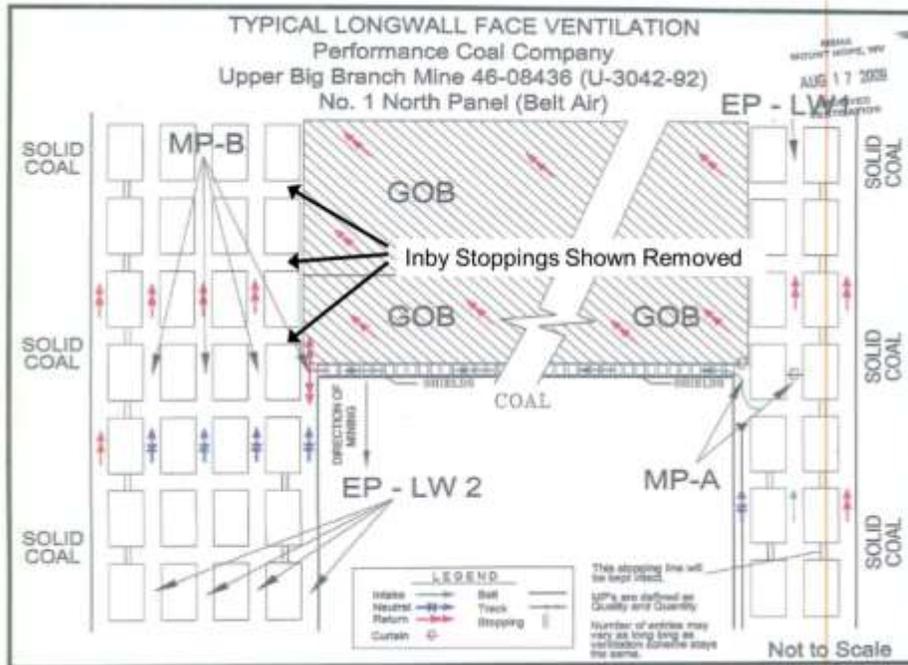
corner, as indicated by the three black arrows. The map in Figure 44 indicates that the return air from the face would split at the tailgate, but the outby split would only extend to the next open stopping, i.e., for about 50 ft. from the tailgate corner. From these conflicting map images, it remains unclear what is to be considered the approved ventilation plan.

Figure 44: UBB map showing typical longwall face ventilation, Base Ventilation Plan and Annual Map - Part 1 - approved on 9-11-2009.
