# Lessons Learned from Mine Disasters: New Technologies and Guidelines to Prevent Mine Disasters and Improve Safety

By Jürgen F. Brune and Benjamin Goertz

## A Research Report

Colorado School of Mines, Mining Engineering Department

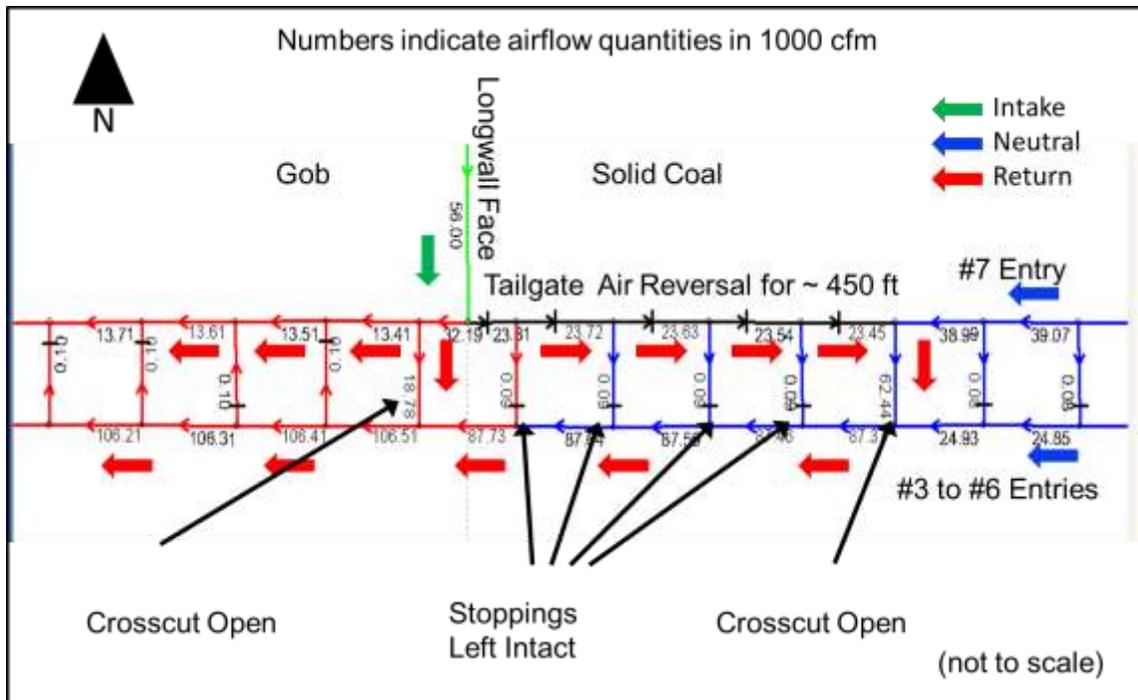
A detailed ventilation model (Figure 45) generated specifically for the tailgate area demonstrates that this practice of removing only selected stoppings would lead to a splitting of the return airflow coming from the longwall tailgate.

A portion of the air flows inby and towards the bleeders while the remainder of the air flows outby towards the first available open crosscut, where it merges with the tailgate air. Depending on the location of the nearest open crosscut, the air reversal on No. 7 entry could extend over 5 crosscuts or up to 500 ft., as shown in Figure 45. Here the red arrows in No. 7 entry east (outby) of the longwall face indicate the path the tail air must take before it finds the nearest open crosscut to flow into the No. 3 to 6 entries and on to the bleeders.

Such a condition was indeed found and documented on March 10, 2010, when an MSHA inspector checked the airflow direction in No. 7 entry just outby the longwall tailgate. According to the inspector's notes<sup>12</sup>, the No. 7 entry tailgate airflow immediately outby the face flowed outby from the face for four crosscuts or about 400 ft. Further outby, the tailgate airflow was according to the ventilation plan (i.e., flowing inby).

Figure 45: Ventilation model illustrating reversal of tailgate air. Numbers indicate airflow quantity in 1000 cfm.

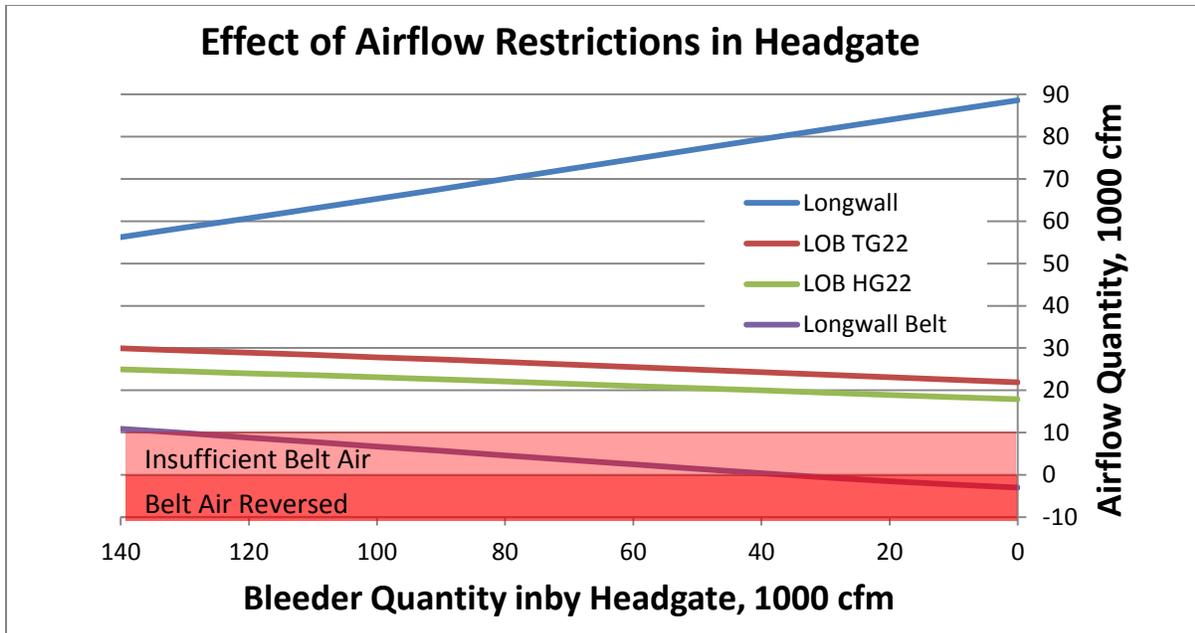
Figure 46 shows the results of modeling a resistance increase in the headgate that could be caused by roof deterioration, floor heave, and/or water pooling in low-lying areas and would lead to reduced airflow through the headgate bleeder system inby the longwall panel. The mine map<sup>13</sup> shows such water pooling in No. 3 entry of the headgate from break No. 71 to break No. 75. Also, the report by the WV Governor's Independent Investigation Panel (McAteer, 2011) indicates that, on the day of the explosion, water pumps had failed in both the longwall headgate and tailgate.

As expected, higher resistance in the headgate would increase the face quantity, since more air would be available at the headgate and the bleeder fan would pull harder on the longwall tailgate exhaust. Since, at the time of the explosion, the returns of the TG 22 and HG 22 development sections also ventilated to the longwall headgate bleeder, the LOB quantities of these sections would be significantly reduced if the headgate was closed off. In general, reducing airflow due to blockage in a longwall headgate would render the bleeder system ineffective since there would not be sufficient air available from the headgate side to dilute methane in the gob.

Figure 46: Effect of resistance in headgate bleeder entries.

Figure 46 also shows that the longwall belt air quantity, flowing away from the face, would be affected significantly if there were a restriction in the headgate. If the headgate flow was restricted below about 33,000 cfm, the belt air would reverse.

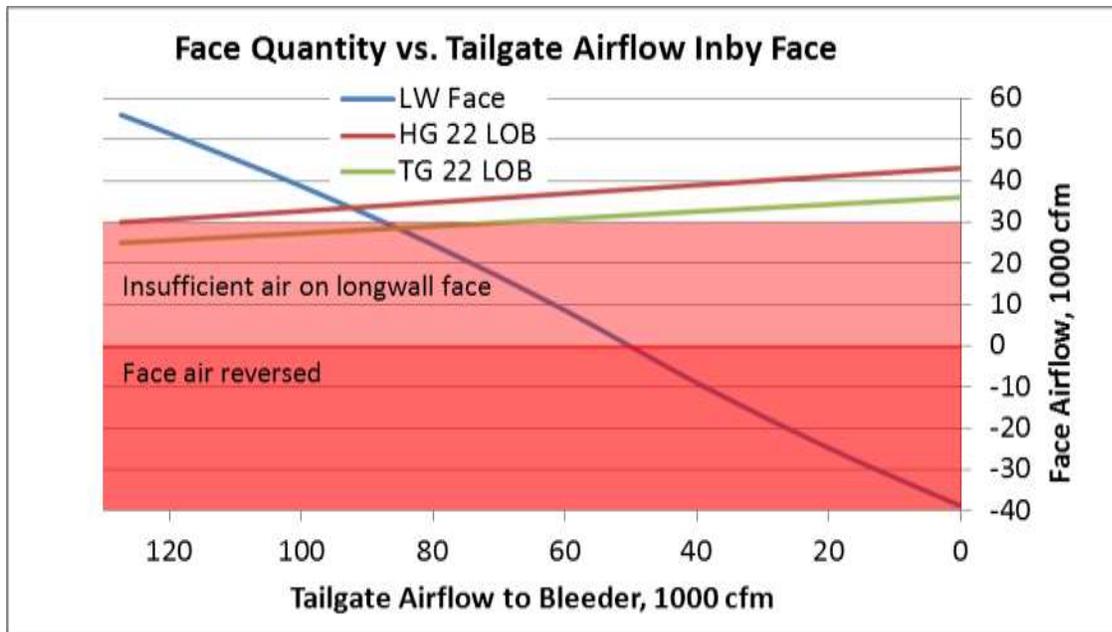
Ventilation modeling indicates that the longwall face quantity has a strong dependence on the tailgate bleeder airflow capacity. If the tailgate bleeder flow is restricted inby the face, the longwall face quantity is significantly reduced and will eventually reverse. Such restrictions could be caused by roof falls, convergence and accumulation of water, as discussed above. According to McAteer (2011), the UBB maintenance superintendent testified during the MSHA investigation that pumps in both the headgate and tailgate had failed during the weekend prior to the explosion. A strong airflow in the tailgate bleeder is therefore most important to maintaining sufficient airflow on the face. These dependencies are illustrated in Figure 47.

A restriction causing about 40% less airflow on the tailgate would reduce the face quantity to below the statutory minimum of 30,000 cfm. If the flow was restricted by more than about 60%, the air on the longwall face would reverse. As Figure 47 documents, a loss of 20,000 cfm flow in the tailgate would reduce the longwall face quantity by approximately 15,000 cfm.

Figure 47 also shows that longwall tailgate restrictions will lead to increases in LOB airflow on the HG 22 and TG 22 development faces since the Bandytown bleeder fan would be forced to pull on these returns at higher pressure, and since additional intake air is available due to the flow reductions on the longwall.

Figure 47: Longwall and continuous miner development face airflow as a function of tailgate bleeder airflow inby the face.

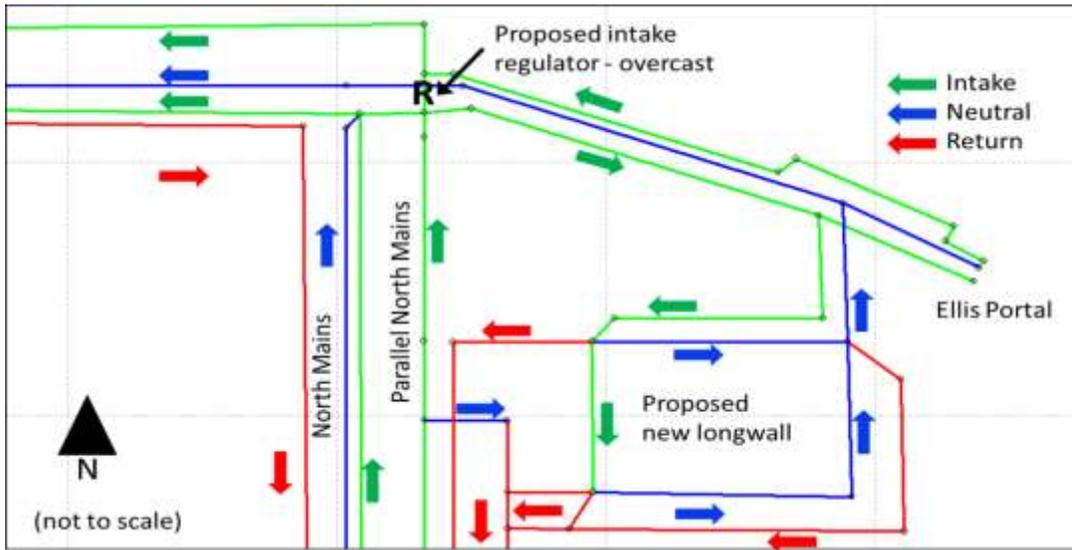
Figure 48: Schematic view of intake regulator in North Mains based on revised map, phase 2, revision B6-A17, approved on 02-16-2010

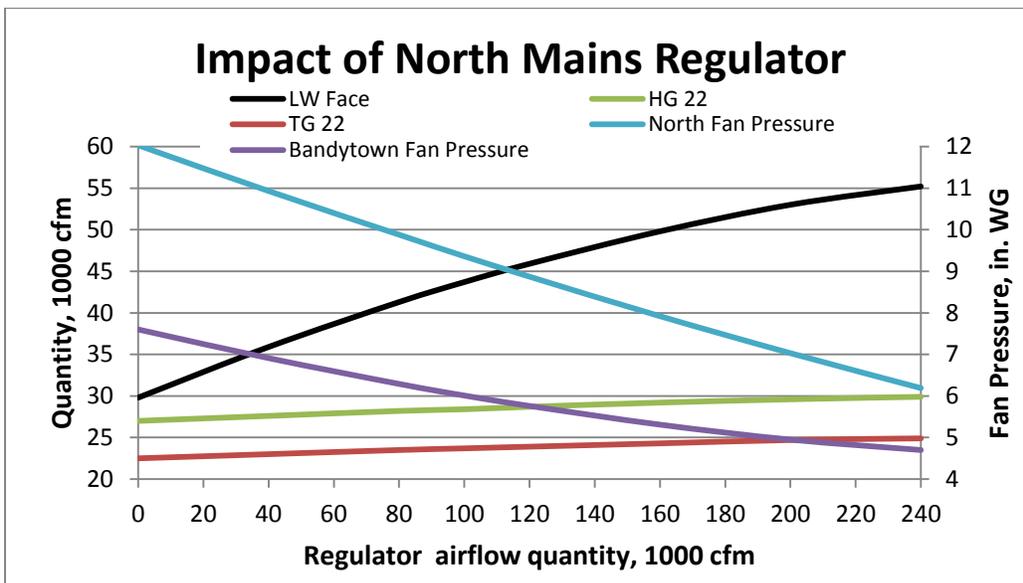
The graphs in Figure 49 display the airflow quantity and fan pressure changes that would be caused by changing the regulator quantity. They show that reducing the flow at the North Mains regulator would have reduced the airflow available at the longwall face as well as the LOB quantities at the HG 22 and TG 22 development sections. Since closing the regulators would increase the overall mine resistance, the operating pressures of both the Bandytown and North fans would increase, reducing the total fan airflows as well.

The model shows that, if the North Mains regulator was closed to 100,000 cfm of airflow, the longwall face quantity would be reduced to about 44,000 cfm (21%) while the LOB quantities at HG 22 and TG 22 would drop by about 5% each. This reduction may have had a significant impact on the production sections. Such reduction may have also reversed the belt air flowing in No. 7 North belt past the Glory Hole area. This is significant as Also, as noted in the report by the WV Governor’s Independent Investigation Panel (McAteer, 2011), construction foreman Mike Kiblinger testified that, on Monday April 5, 2010, dust was blowing into the mine along the belt line, reversed

from what he had observed on earlier days. The base model confirms this reversal which begins as the regulator is cut below 120,000 cfm.

Figure 49: Impact of North Mains intake regulator on airflow quantities and fan pressures

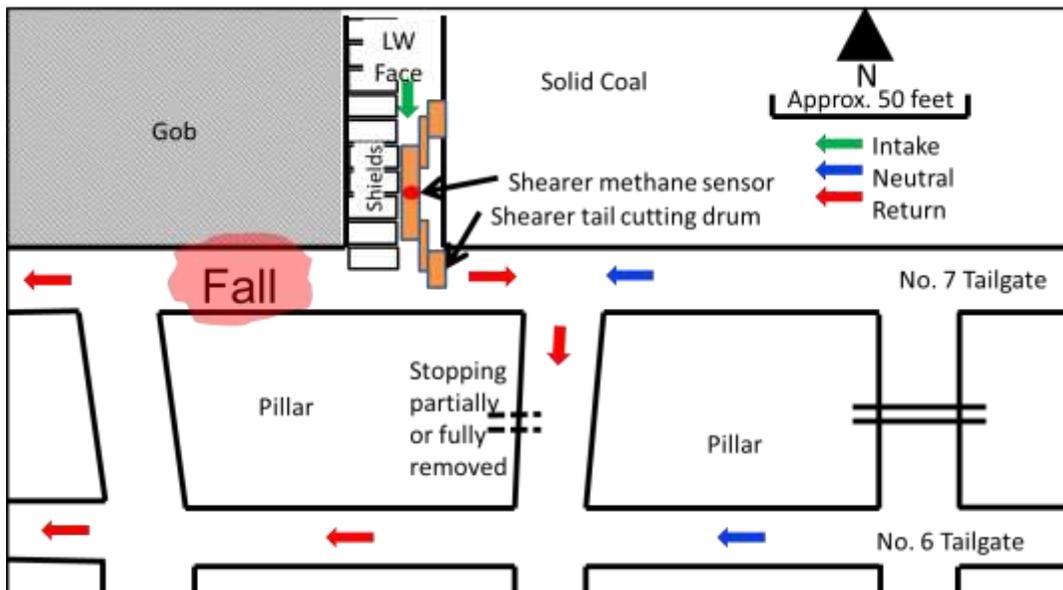
Figure 50 shows the ventilation layout at the tailgate of the Upper Big Branch mine.

Fresh (neutral) air is coming up the No. 6 and 7 tailgate entries. The longwall face air is splitting at the tailgate with one split going directly to the bleeders (left) and the other split going outby, mixing with the neutral air in No. 7 and going through the first outby crosscut where the stopping had been partially removed. A roof fall inby the tailgate likely restricted the flow of the left split into the bleeders based on the findings of MSHA investigators (Page, 2011, p. 44).

Figure 50: Detail of tailgate ventilation at Upper Big Branch prior to the explosion

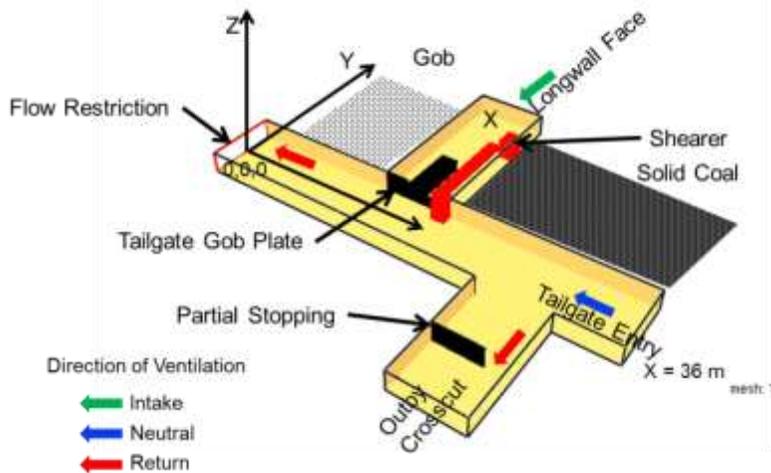
Figure 51 shows an oblique view of the three-dimensional model created in FDS. The model represents the tailgate area shown in Figure 50. Simulations were carried out with various quantities of methane emanating from the gob area behind the shields. These simulations show that a partial or total blockage of the No. 3 entry immediately inby the longwall face may cause explosive air mixtures from the gob behind the shields to be drawn into the face area where they may be ignited by the shearer cutting drum.

Figure 51: Three-dimensional FDS model for the UBB tailgate.

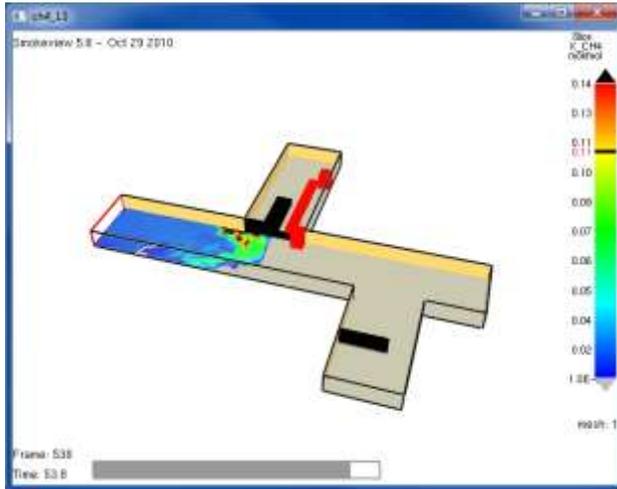
Figure 52 shows the flow status for model run No. 134. The tailgate is wide open with a quantity of about 56,000 cfm ( $26 \text{ m}^3/\text{s}$ ). An eddy is formed in the shadow of the gob plate/windrow, confining the flammable mixture to a limited area behind the gob plate. The simulation shows that, although a significant amount of methane (1,000 cfm,  $0.47 \text{ m}^3/\text{s}$  or 1.25% of the face quantity) flow from behind the shields, the explosive cloud gets diluted quickly below the explosive range as it flows down the tailgate. There is no explosive methane (green to red color range) near the shearer tail drum where it

might be ignited in the cutting process. Note that no significant methane is found near the shearer body where it might trigger a CH<sub>4</sub> monitor alarm, either.

Figure 52: Methane cloud in run 134, 1000 cfm CH<sub>4</sub> (0.47 m<sup>3</sup>/s), fully open tailgate

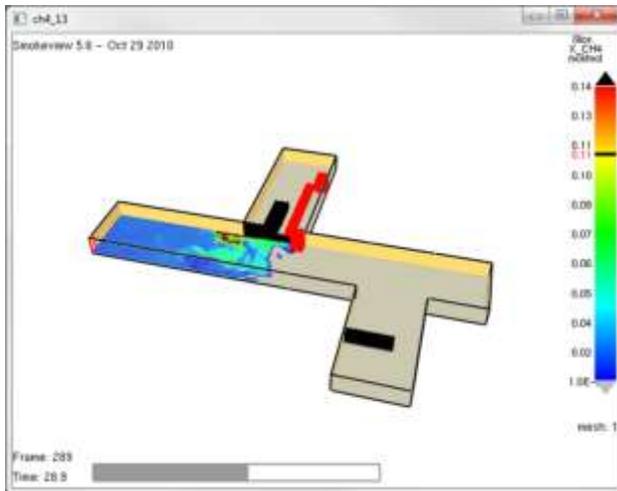
Figure 53 shows the results for run No. 135, using the same methane quantity (1,000 cfm, 0.47 m<sup>3</sup>/s), with the opening to the gob reduced to 1 m<sup>2</sup> (11 ft<sup>2</sup>), equivalent to restricting the flow in the tailgate to about 26,000 cfm (12 m<sup>3</sup>/s) or about half of the original flow. Here it is clearly visible that explosive methane concentrations (green colors) build up close to the tail drum, creating an acute explosion hazard.

Figure 53: Methane cloud in run 135, 1000 cfm CH<sub>4</sub> (0.47 m<sup>3</sup>/s), tailgate opening reduced to 1 m<sup>2</sup> (11 ft<sup>2</sup>)

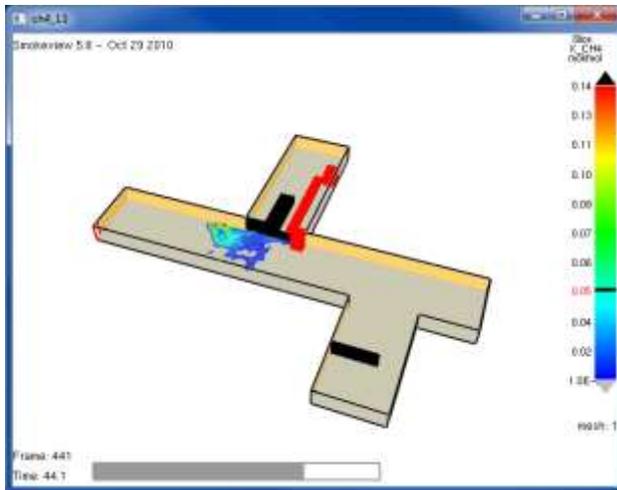
Figure 54 shows the gas cloud for model run 140. In this run the methane quantity was reduced to 250 cfm (0.12 m<sup>3</sup>/s), with the gob opening left at 1 m<sup>2</sup> (11 ft<sup>2</sup>). The gas cloud shows concentrations in the explosive range only in by the face (green colors), but concentrations between 1 and 5% may accumulate behind the gob plate and reach all the way to the shearer.

Figure 54: Methane cloud in run 140, 250 cfm CH<sub>4</sub> (0.12 m<sup>3</sup>/s), 1 m<sup>2</sup> (11 ft<sup>2</sup>) tailgate opening

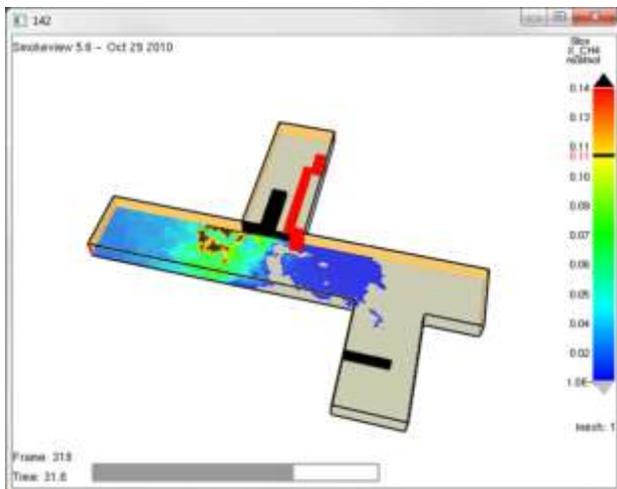
Figure 55 represents model run 142, where the tailgate opening was further reduced to 0.25 m<sup>2</sup> equivalent to about 7300 cfm (3.4 m<sup>3</sup>/s). Methane inflow was left at 1,000 cfm (0.47 m<sup>3</sup>/s). Modeling shows that a significant methane cloud now develops outby the longwall face. Although this cloud appears to be below the explosive range, the modeling succession clearly demonstrates that tailgate restrictions will eventually drive methane accumulations into the tailgate outby the face, where they will enter the nearest outby crosscut.

Figure 55: Methane cloud in run 142, 1,000 cfm CH<sub>4</sub> (0.47 m<sup>3</sup>/s), 0.25 m<sup>2</sup> (2.7 ft<sup>2</sup>) tailgate opening

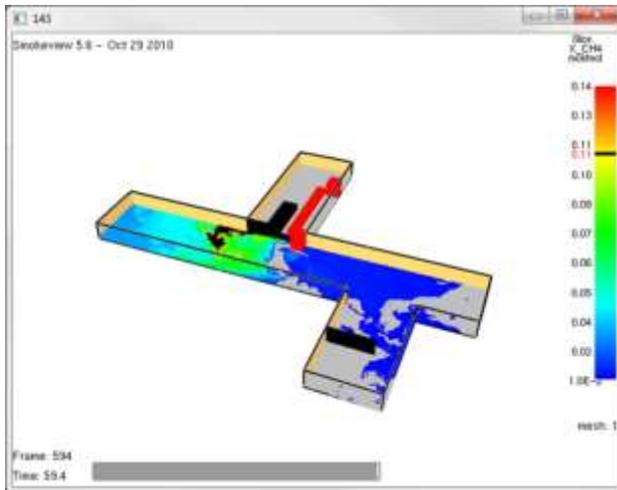
Figure 56 shows model run 143 with the tailgate fully closed and a methane release of 1,000 cfm (0.47 m<sup>3</sup>/s). Compared to Figure 55, there is a more significant methane accumulation in the dead-ended tailgate with explosive concentrations close to the shearer drum. Concentrations outby the face are shown to be below the explosive range. It should be noted that, in all simulated cases, a methane sensor mounted on the body of the shearer (see Figure 50) would not pick up any methane since it is always in fresh air.

Figure 56: Methane cloud in run 143, 1,000 cfm CH<sub>4</sub> (0.47 m<sup>3</sup>/s), tailgate opening closed

Based on the results of these models, researchers recommend keeping the immediate longwall tailgate entry open at least to the nearest inby crosscut so that positive ventilation is maintained inby the face to dilute and carry away any methane released behind the shields.

Researchers recommend re-evaluating the locations of methane monitoring sensors on longwall equipment to ensure that dangerous concentrations of methane near the shearer cutting drums will be detected before they can be ignited by the cutting drum.
