Mine Safety Impoundment Inspection and Verification Tool: Phase I Final Report

Mining and Industrial Safety Technology and Training Innovation (MISTTI)

Keywords: coal impoundment, impoundment inspection, dam safety

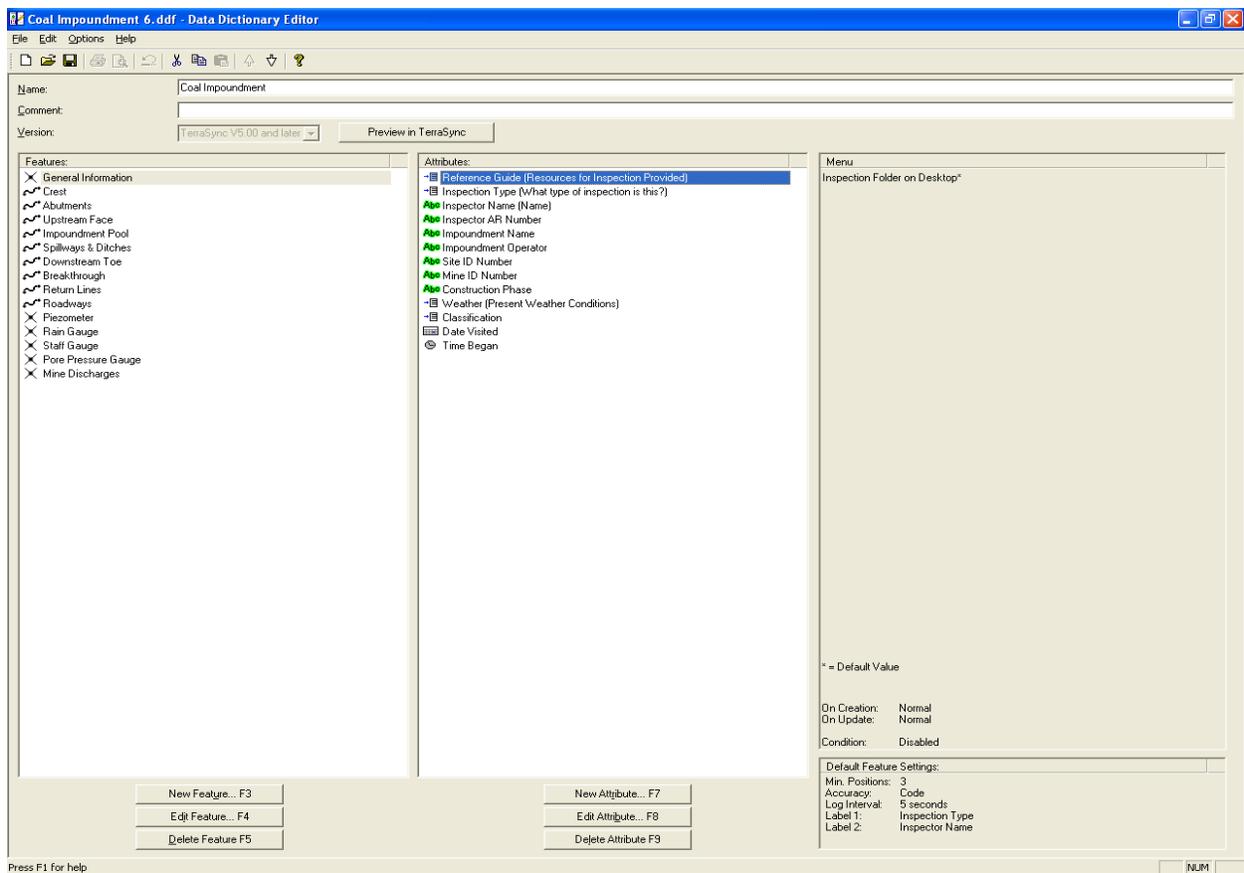
Figure 1: General Information feature and coinciding attributes.

Following the installation of Trimble's Pathfinder Office and Terrasync software programs, a data dictionary was created for use by the inspector in the field. The data dictionary contains all the necessary text fields for completing a routine coal impoundment inspection. A form created in Microsoft Excel (Appendices I and II) was used as a template for the electronic form later structured in Trimble Pathfinder Office software. The automated inspection process begins with the creation of a data dictionary using Pathfinder Office. The data dictionary serves as the template used with the Trimble Yuma in the field and consists of only features and attributes. Each feature in the data dictionary may serve as a portion of the coal impoundment. For example, crest, downstream toe, and piezometer could all be considered individual features because each portion of the impoundment has particular criteria to be evaluated during an inspection. Each feature may be set to record in the field as a point, line, or area. The concept of features and attributes may be viewed in Figure 1.

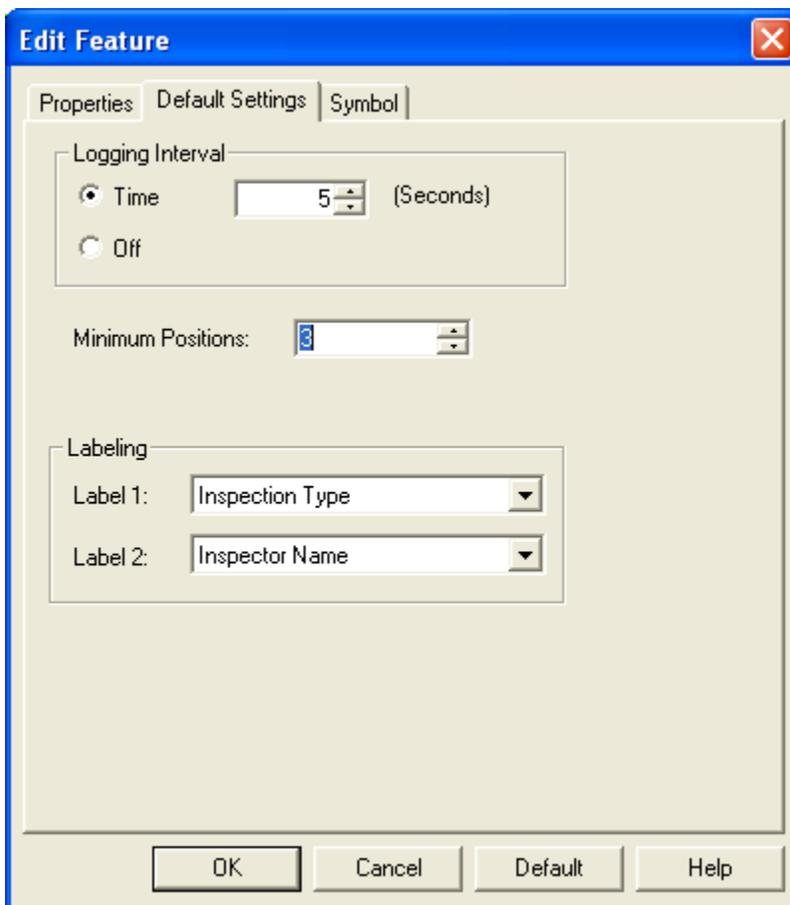
Figure 2: Minimum position setting on point feature.

Point and line features were employed in the impoundment dictionary because using an area feature requires the inspector to make nearly a full loop in order to close a polygon and record an area. The use of an area feature is equally inappropriate because the main purpose of recording locations for each feature is to monitor the inspection route traveled as well as make it more efficient to locate potential hazards during maintenance. Most features were set to record as lines with a recording interval of five seconds while others, such as piezometers, pore pressure gauges, and mine discharges, were recorded as points with the same recording interval. An additional setting was enabled with point features however (Figure 2). The point features were required to contain a minimum of three recorded locations to improve accuracy by allowing Pathfinder Office to differentially correct the data back in the office. In fifteen short seconds, the three positions will be recorded; therefore, the inspection is not delayed because the inspector most definitely spends more than fifteen seconds recording the point IDs and numerical values for gauges and discharges.

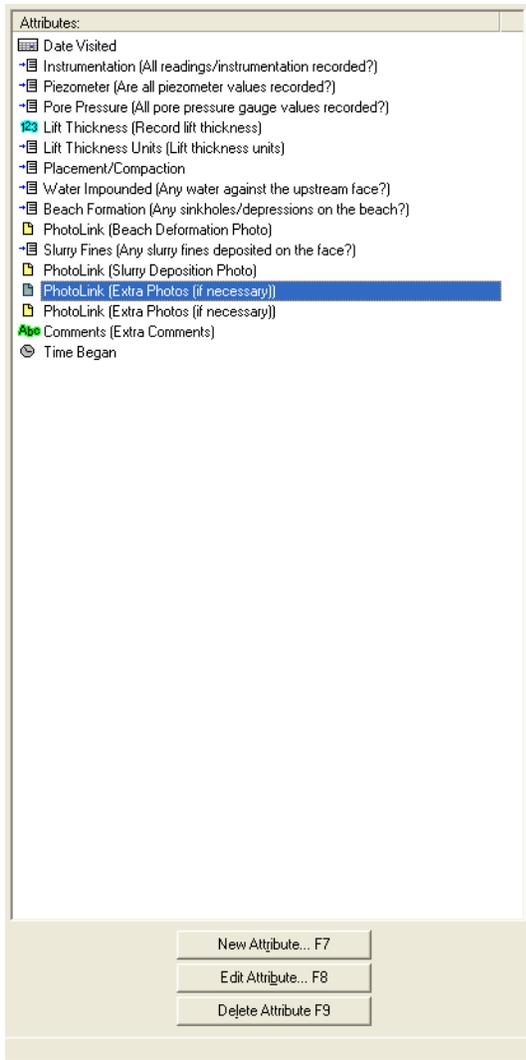
Figure 5: Attributes for additional photos/comments.

Photo links are part of the Pathfinder Office program for storing photographs as well as video with audio within the data file. When the links are selected in the field, the camera utility opens, allowing the user to capture a photograph. Within the camera utility, the option for capturing video is present. Taking advantage of this option allows the inspector to capture a video with an oral description of the observance or problem. Additional fields are provided as well for extra comments or additional photos (Figure 5).

Time and date attributes may be appended to each feature for the purpose of data organization in the office and monitoring inspection practices (Figure 5). The time and date fields may be automatically generated and locked so that the inspector may not change them in the field (Figure 6). The use of

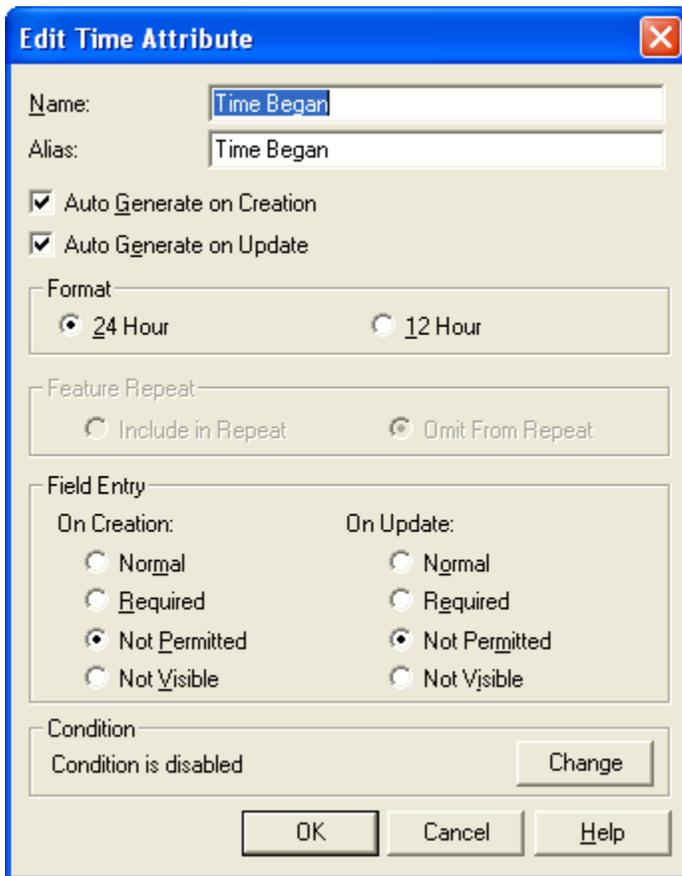
Figure 6: Auto-generated time attribute (notice field entry is not permitted).

automatic generation validates the date and time that each feature of the impoundment was inspected. Taking the difference between times allows the capability of showing how much time was spent inspecting each feature of the impoundment. Additionally, each five-second location recorded has a time affixed by the GPS unit; therefore, these data may be used for monitoring the time delay between ending one feature and beginning another to confirm the inspector is applying his time efficiently.

Each attribute in the Pathfinder Office data dictionary contains settings related to security and conditional situations. Notice the field entry box in Figure 6. Attributes may be configured so that they are not permitted to receive an answer, such as the time and date stamp attributes. The time and date attributes are automatically generated; hence, the inspector does not have permission to alter them in any way. Each attribute may be set so that the inspector chooses to input an answer for the question. Attributes may be required instead, forcing the inspector to provide an answer in order to make sure he/she does not accidentally miss the question. Most attributes in the coal impoundment dictionary were created as required fields to ensure all questions are answered. There are some required attributes, however, that are not visible unless the inspector provides a particular answer to a question. Some attributes may be set so that they are not visible unless another attribute is given a specific response. Notice the condition box in Figure 6. For example, if the inspector answers that there is erosion on a spillway of the impoundment, then he or she will be prompted to provide a description of

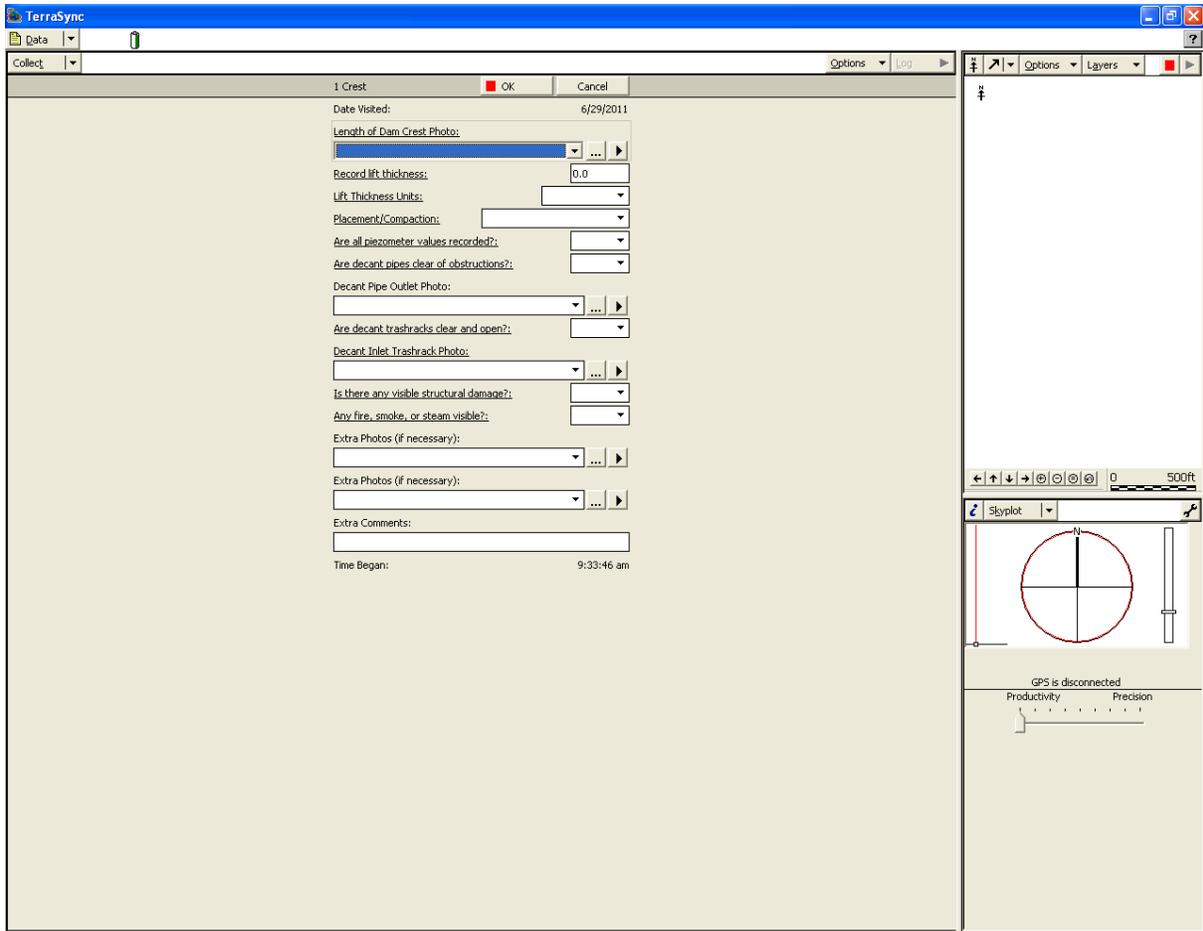
Figure 7: Screen shot of template in Trimble Terrasync.

Each feature and attribute in the data dictionary contains a field for a title as well as a description. The title is used primarily for the manipulation and organization of data in the office while the description of the feature is seen on-screen while performing an inspection. Only the description can be viewed in Trimble Terrasync, thus all pertinent information to each question must be portrayed in the description field so that it may be understood in the field. Figure 7 (below) demonstrates what the inspector sees on screen while performing a routine inspection.

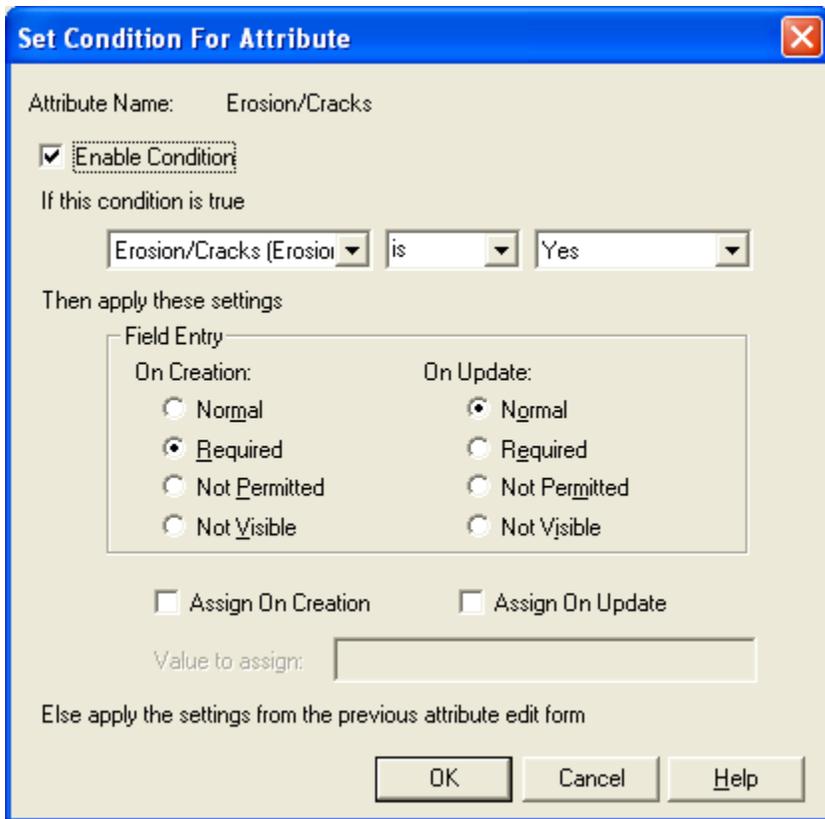
Figure 8: Conditional setting for describing erosion based on answer that erosion is present.

where and what was observed. The inspector will also be prompted to take a photograph of the observance, which will contain matching coordinates. Conditional settings are used in the data dictionary utility to create questions that only pertain to specific situations. In the case of erosion, the description attribute contains a conditional setting, which can be selected so that the description attribute is only visible if the inspector provides that there is erosion (Figure 8). Any attribute following another may be set so that it only appears depending on the answer provided to the first.

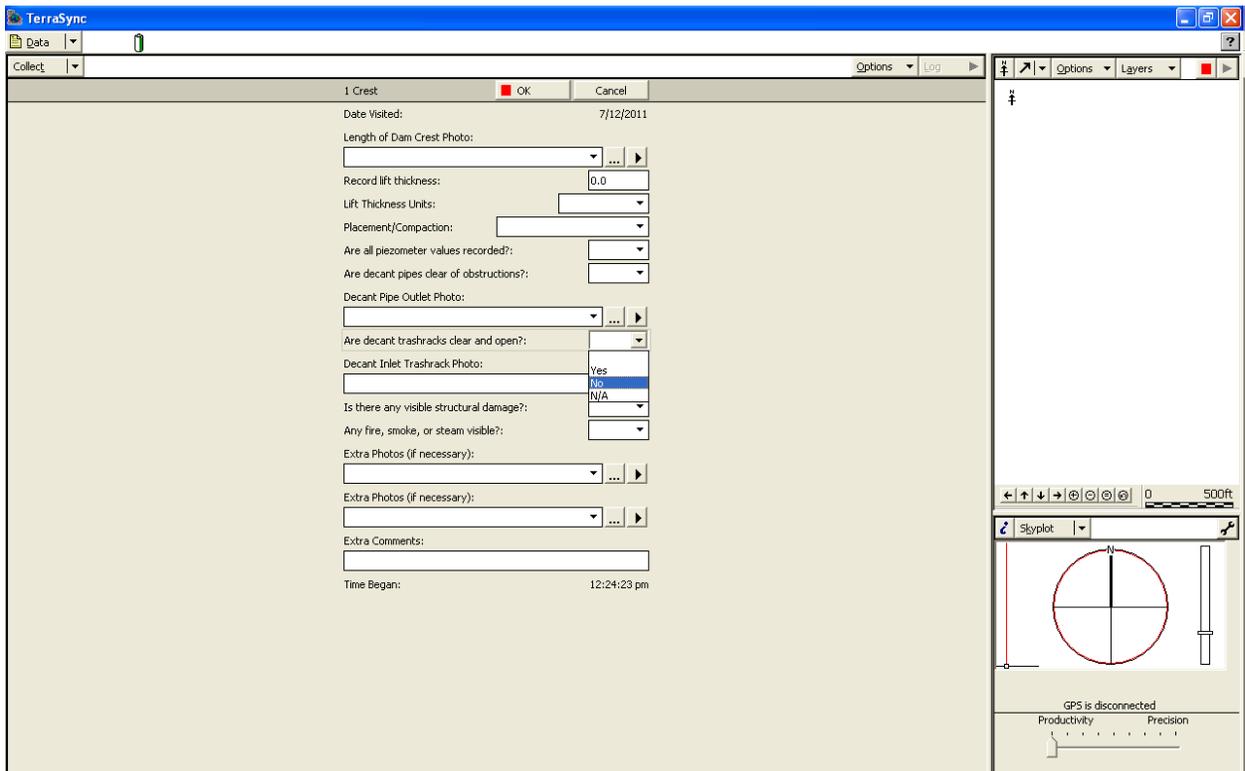
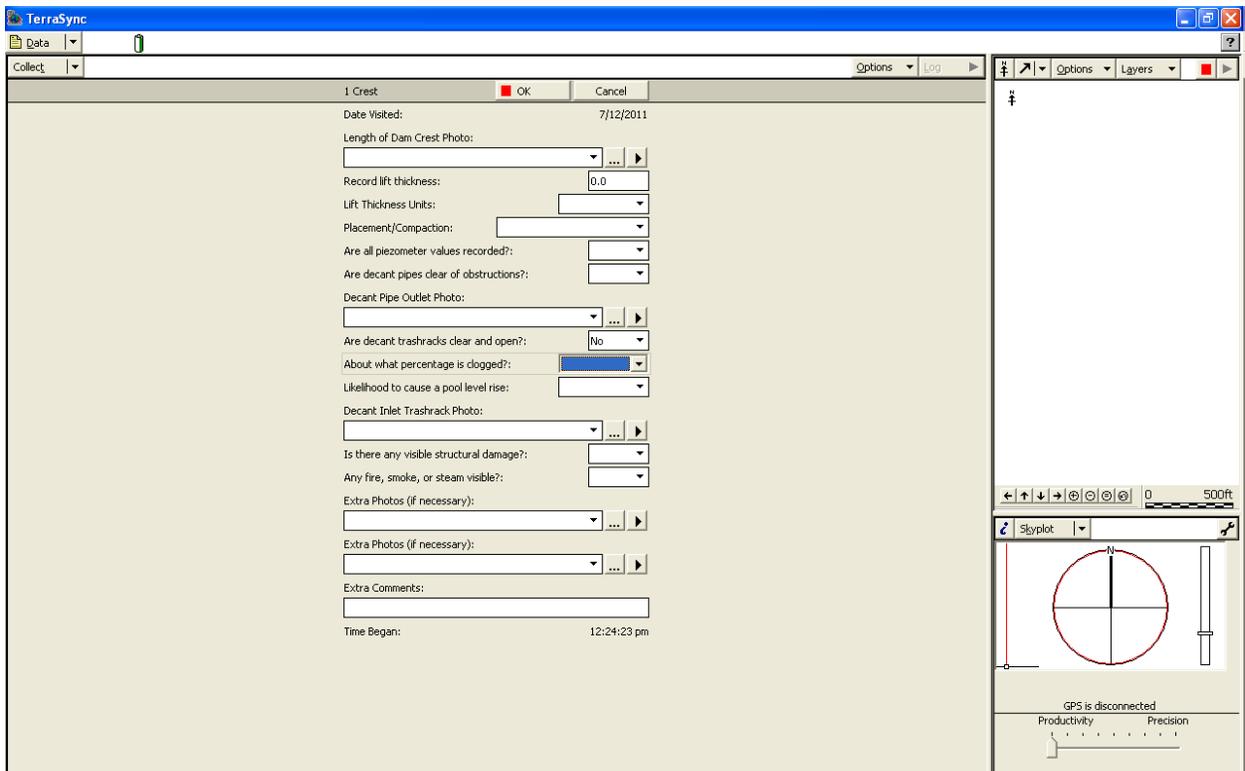
Figure 9: Illustration of conditional attributes appearing after answer was provided that trash racks are not clear and open.

Poor risk assessment and negligence are equally important to the improvement of inspection procedures as both have caused catastrophic failures recently. Involving features to assist in risk assessment and including these fields in the output report are both essential to the improvement of inspection practice. Additional attributes were included involving decant trash rack clogging and spillway/groin ditch obstructions. One attribute prompts the inspector to provide an estimate of the likelihood of each instance causing a pool level rise, while another requires an estimate of the clog as a percentage if the inspector claims that the trash rack or spillway is obstructed in some way. Both of these attributes are conditional in that they only appear if the inspector answers that the decant trash rack is not clear and open (Figure 9). Once the inspector answers that the trash rack is not clear, the additional questions appear regarding clogging percentage and likelihood. If the inspector answers that the rack is over 50 percent clogged, then a third conditional attribute will appear directing the inspector to notify the mine manager immediately. These three attributes function in the final report as a risk assessment tool for determining what level of risk the feature has on the impoundment.

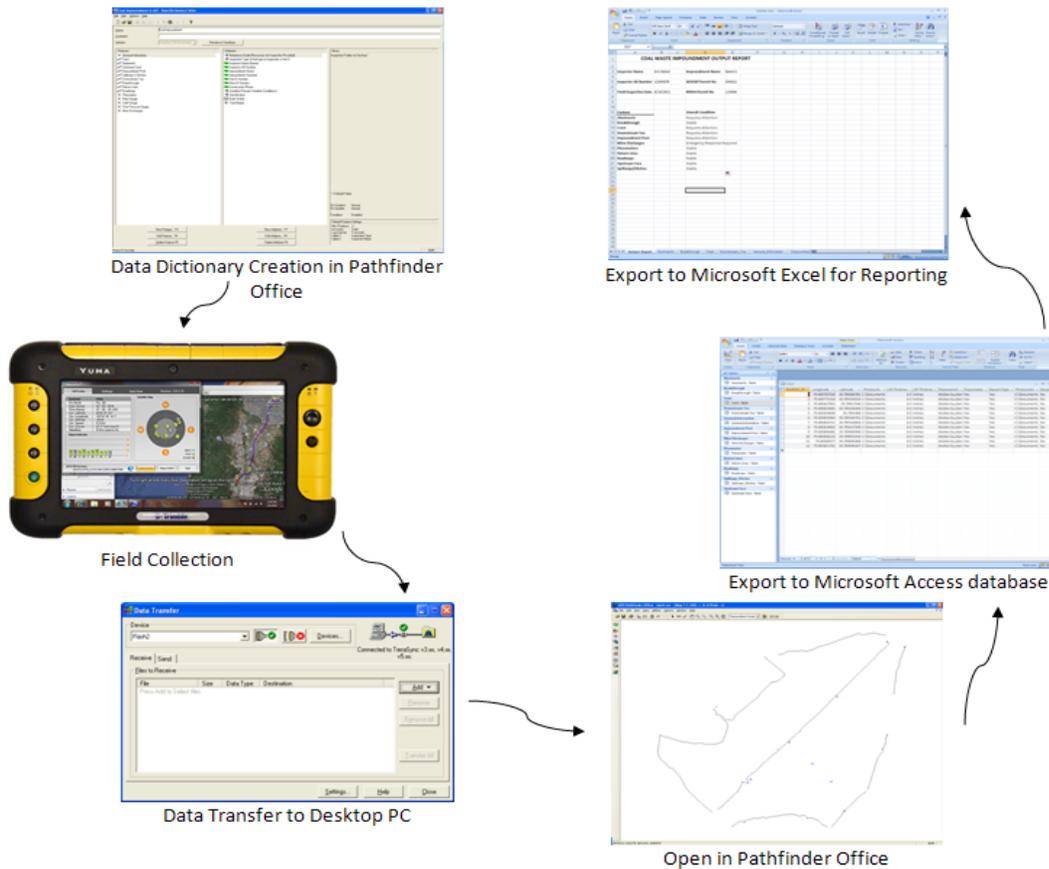
Figure 10: Flow chart showing basic electronic data collection process.

The inspector can simply open the Terrasync program and access the correct data dictionary to begin the inspection. The template is completed during the inspection by answering the questions provided. The inspection file saves to the default location on the Yuma unless otherwise specified. After the inspection, the data file on the Yuma may be saved on a portable storage device (flash drive, SD card, etc.) if it was not already configured to do so and sent to a desktop PC using the Trimble Data Transfer program. If the data transfer link was previously made to the storage device, the data transfer may be

performed similarly to the data dictionary. The eight files created during the inspection will be sent to the desktop PC as one compressed file for viewing in Pathfinder Office. Following the data transfer, the data may be opened in Pathfinder Office, which is primarily used for mapping the inspection route and exporting to other software programs. The complete process is illustrated in Figure 10.

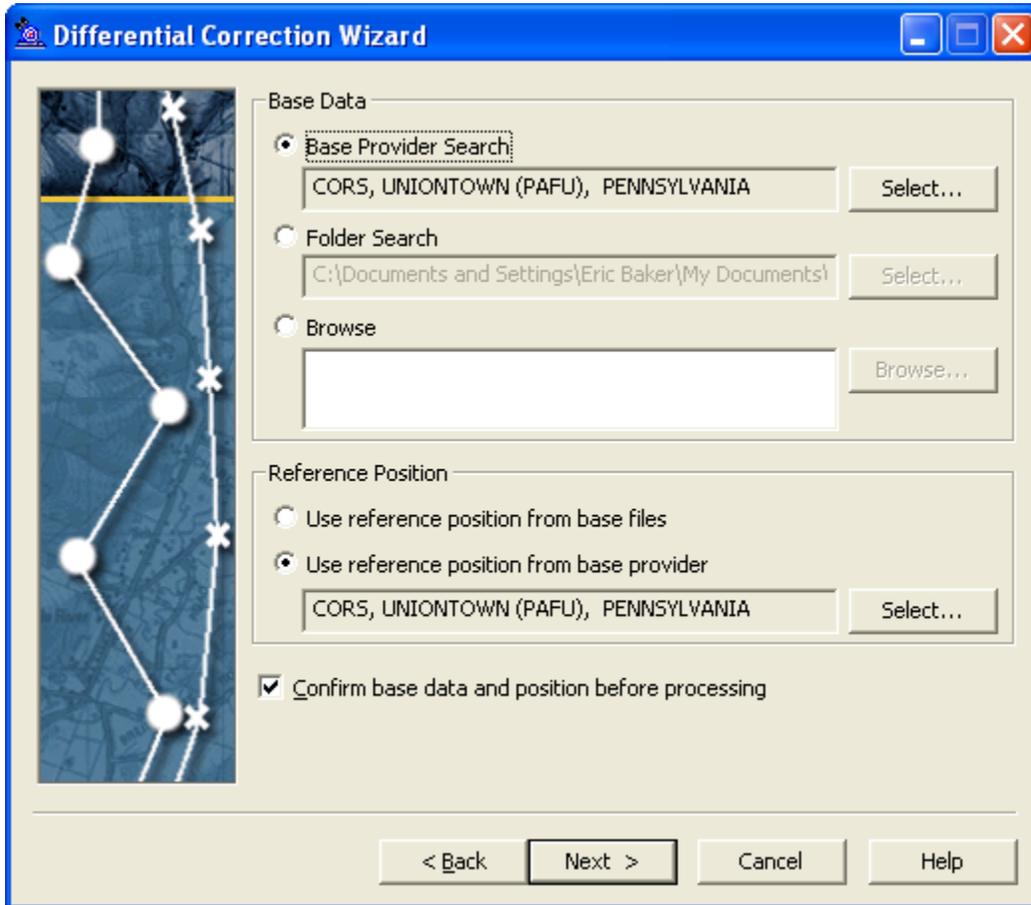
Figure 11: Differential Correction Wizard showing Uniontown, PA CORS station.

After the three inspections were completed for each series, the data was returned to the office for uploading and report generation. The portable flash drive used for the inspection data save location was inserted into the desktop PC, and the Trimble data transfer utility was employed for uploading the data files into their respective locations. Once all three files were uploaded onto the desktop PC, each file was opened separately within Trimble Pathfinder Office. Each file was opened first for viewing, and differential correction was used to enhance the accuracy of the GPS locations collected during the inspection. A base station located in Uniontown, PA was used for differentially correcting the series of inspections (Figure 11). At least 67% of the recorded positions for Pedlar and 80% for Hibbs Run were corrected within two to five meters, which is the best accuracy the Trimble Yuma can accomplish. The correction reports are in Sections 4.1.2 and 4.2.2. The differential correction utility can create a new file for each inspection with the same file name and a new file extension, or it can overwrite the original

shape file depending on what option is chosen. For all inspections, the option was chosen to create a new file so the original data was kept unmodified.

Following the differential correction, the original shape file was closed and the corrected file was opened. Only minor changes exist between the original and corrected shape files, most of which cannot be seen by the user unless one file is placed over the other, which demonstrates the high precision GPS feature of the Yuma. For the purpose of impoundment inspection, the differences are insignificant because the mapping is mostly for monitoring inspection routes. Background files were then added into the inspection file using aerial images provided by the Environmental Systems Research Institute (ESRI). A world imagery layer was first uploaded into ArcGIS 9.3 from the ESRI website. The impoundment was located next and zoomed to so that the impoundment was visible and all the data recorded would be displayed on the map.

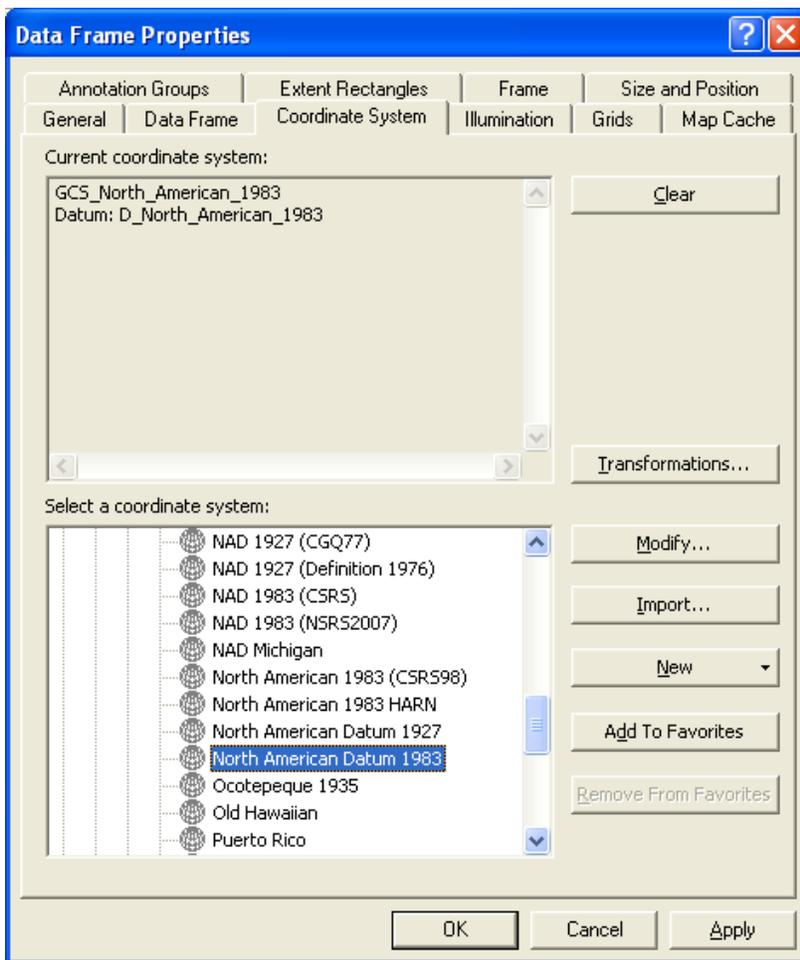
Figure 12: Changing of world imagery coordinate system in ArcGIS to match recorded inspection routes.

Before using the imagery file in the Trimble software, the coordinate system was checked to ensure that it was displayed in the NAD83 coordinate system, and it indeed was not after a quick assessment. The coordinate system was transformed from WGS1984 to NAD83 (Figure 12) because all inspection data files were recorded in the NAD83 coordinate system and using two different coordinate systems is not allowed by Pathfinder Office. The transform utility in ArcGIS was found within the coordinate systems section of the data frame properties. The export utility within ArcGIS was used to save the imagery as a .tiff file so that it could be opened by Trimble Pathfinder Office. A world file was also required for opening in Pathfinder Office so that imagery pixels were matched correctly to geographical coordinates (Figure 13). The world file was easily created by ArcGIS by indicating that a world file was necessary. ArcGIS created the .tiff file of the GIS map window display with an attached world file.

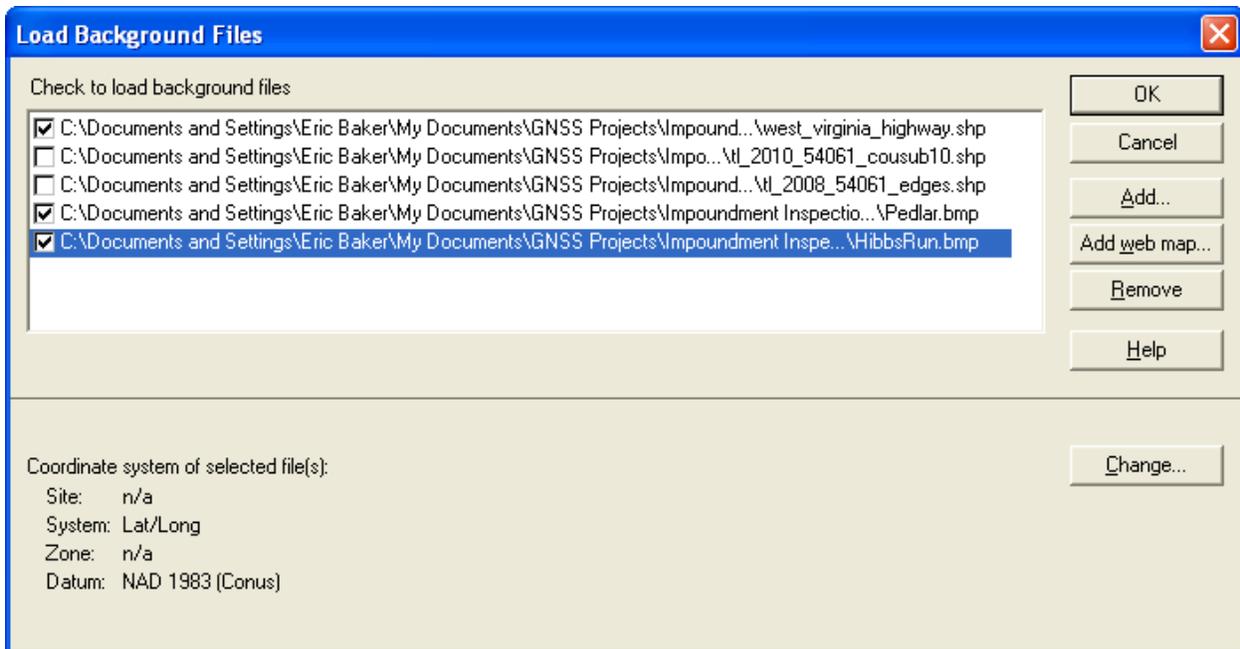
Figure 14: Adding imagery map into Pathfinder Office as background file.

The imagery file was opened in Pathfinder Office by locating it through the background option in the software (Figure 14). The aerial image was uploaded correctly and all data was displayed over an image of the impoundment. Without these imagery files, the route mapping is virtually irrelevant because it is impossible to see where the mapped routes fall on the impoundment. Using the imagery file ensures that the mapped routes were in fact on the impoundment site and the inspector inspected each required portion of the impoundment.

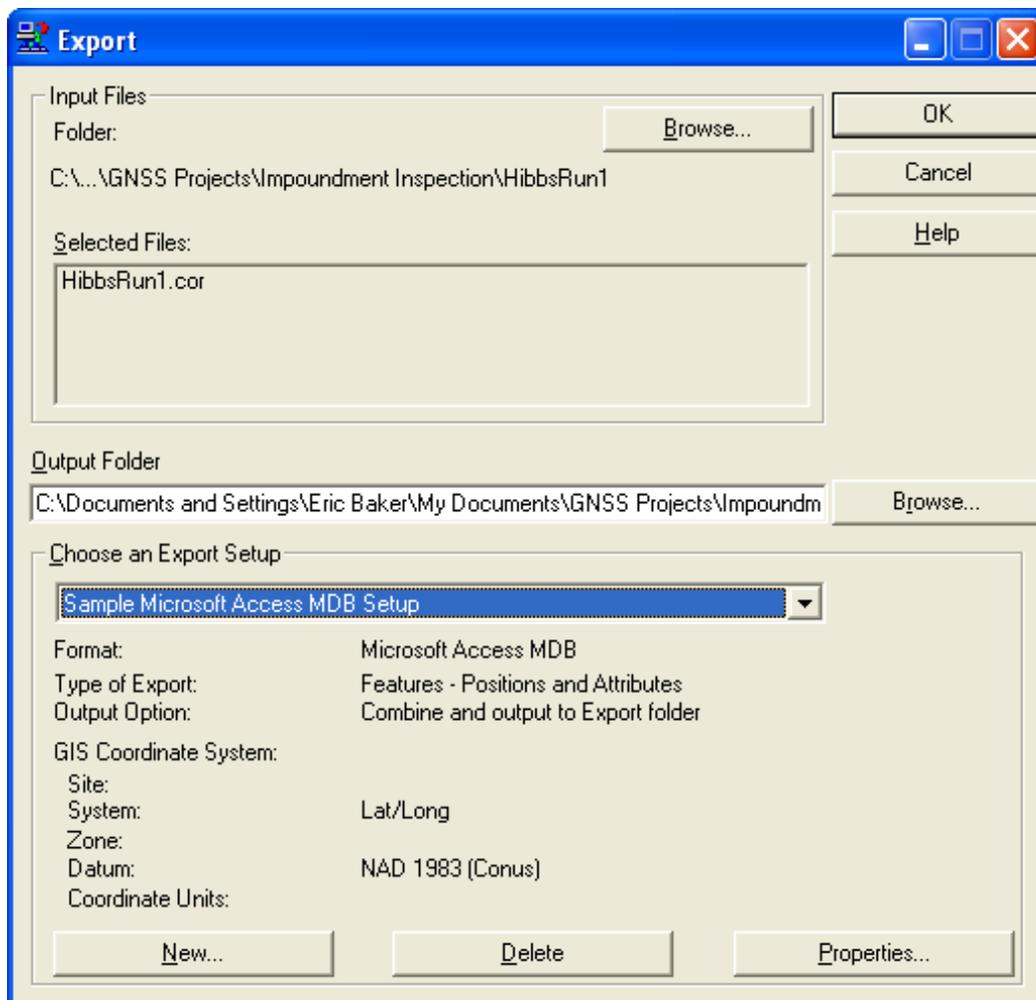
Figure 15: Use of Pathfinder Office export utility to create Access database for inspection.

Once the data file was combined with a background file, the attribute information was exported into a Microsoft Access database. The Trimble export utility was used to perform this task efficiently (Figure 15). After creating the Access database composed of all the necessary attributes, the file itself was opened and reviewed. The Access database was used primarily for organizing the information to be stored as a historical archive. In Access, the data is all present; however, it is not displayed for rapid assessment and for obtaining signatures from mine officials (see Sections 4.1.3 and 4.2.3).

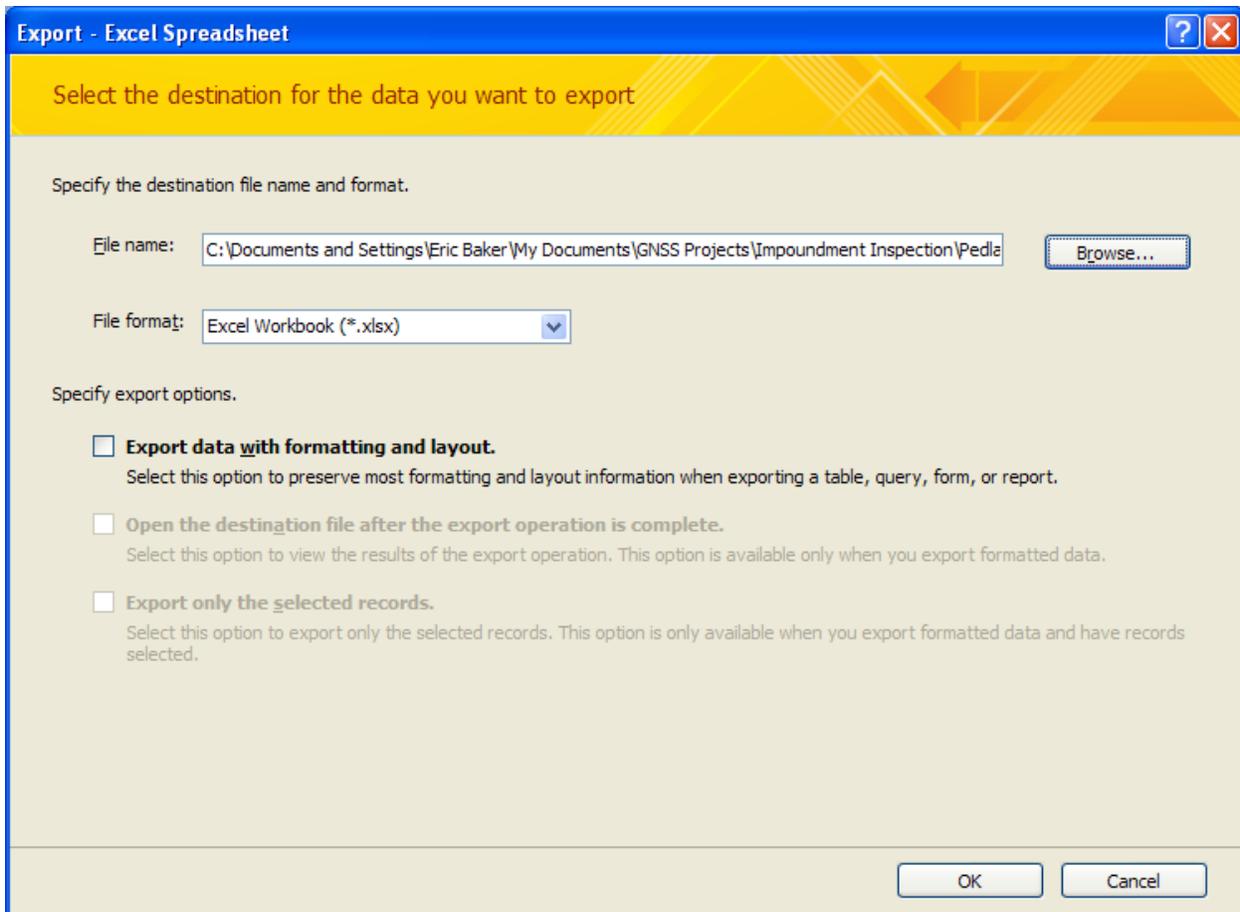
Figure 16: Use of Access export utility to create Excel file for inspection.

In order to meet these requirements, the data was exported from Access to Excel (Figure 16). In Excel (Version 2007), individual worksheets may be linked to a master report template for rapid printing. A master report template was created in Excel with links to each worksheet tab (see Sections 4.1.4 and 4.2.4). All the necessary questions on the MSHA inspection form, portrayed on the Excel inspection form located in Section 8.1, were appended to the master form and linked to answers provided during the inspection. The output report was completed in Excel for printing so that it could be signed by an official for the impoundment, which is a federal regulation dealing with impoundment inspection practice.

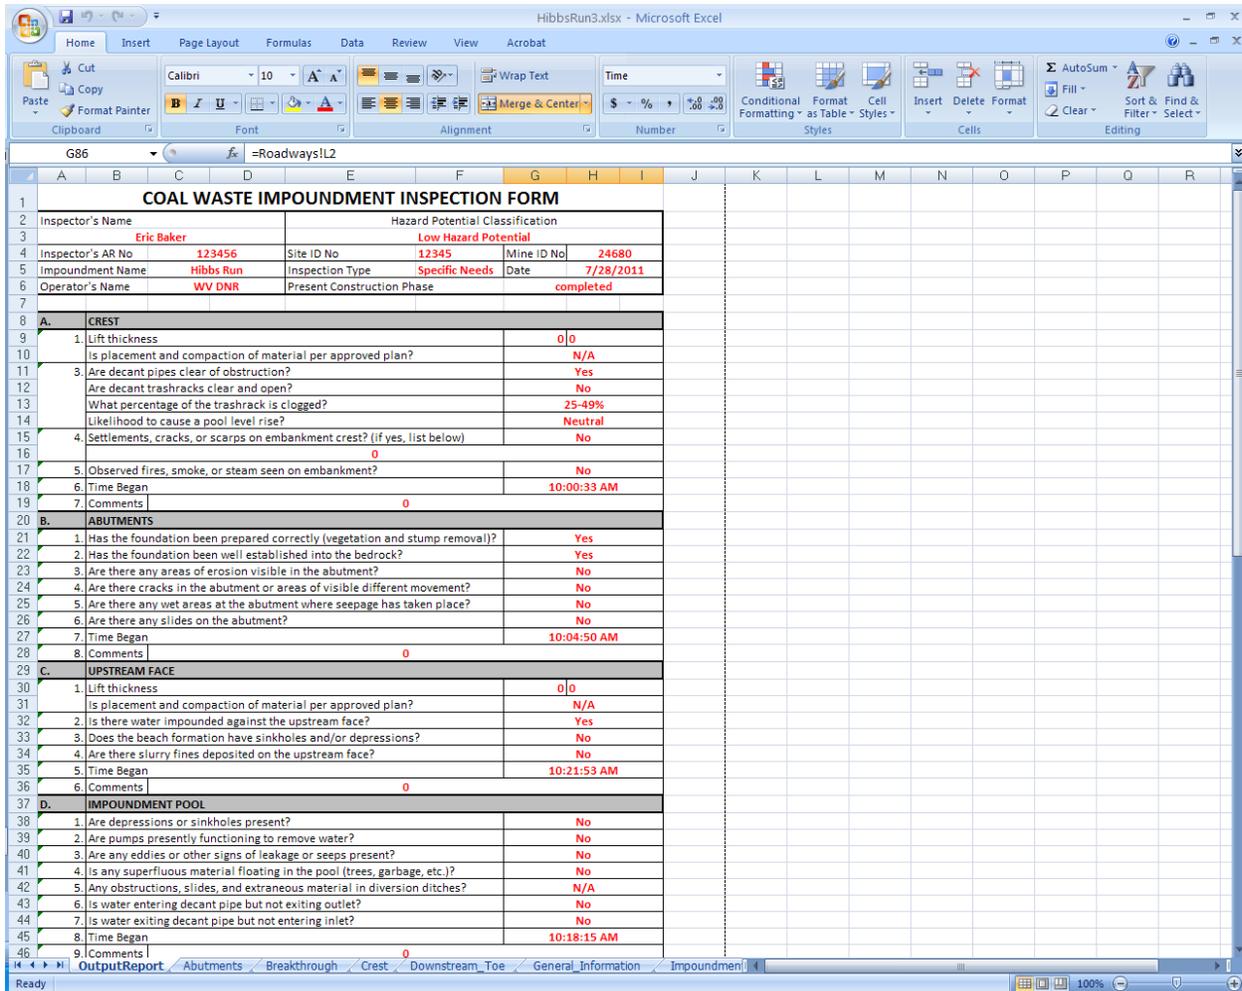
Figure 18: Output report template tab inserted into inspection excel file.

When the attribute information was exported to Excel and the output report template was attached (Figure 18), it was difficult to link the report information to particular cells on the worksheet containing the crest information because the first part of the feature included only some of the answers. The information was not the same throughout multiple inspections; therefore, it was impossible to know which cells would contain the correct information to be viewed on the final output report. Without the ability to automatically populate the output report, the Excel form is not useful for obtaining a hard copy for rapid assessment and official signatures.

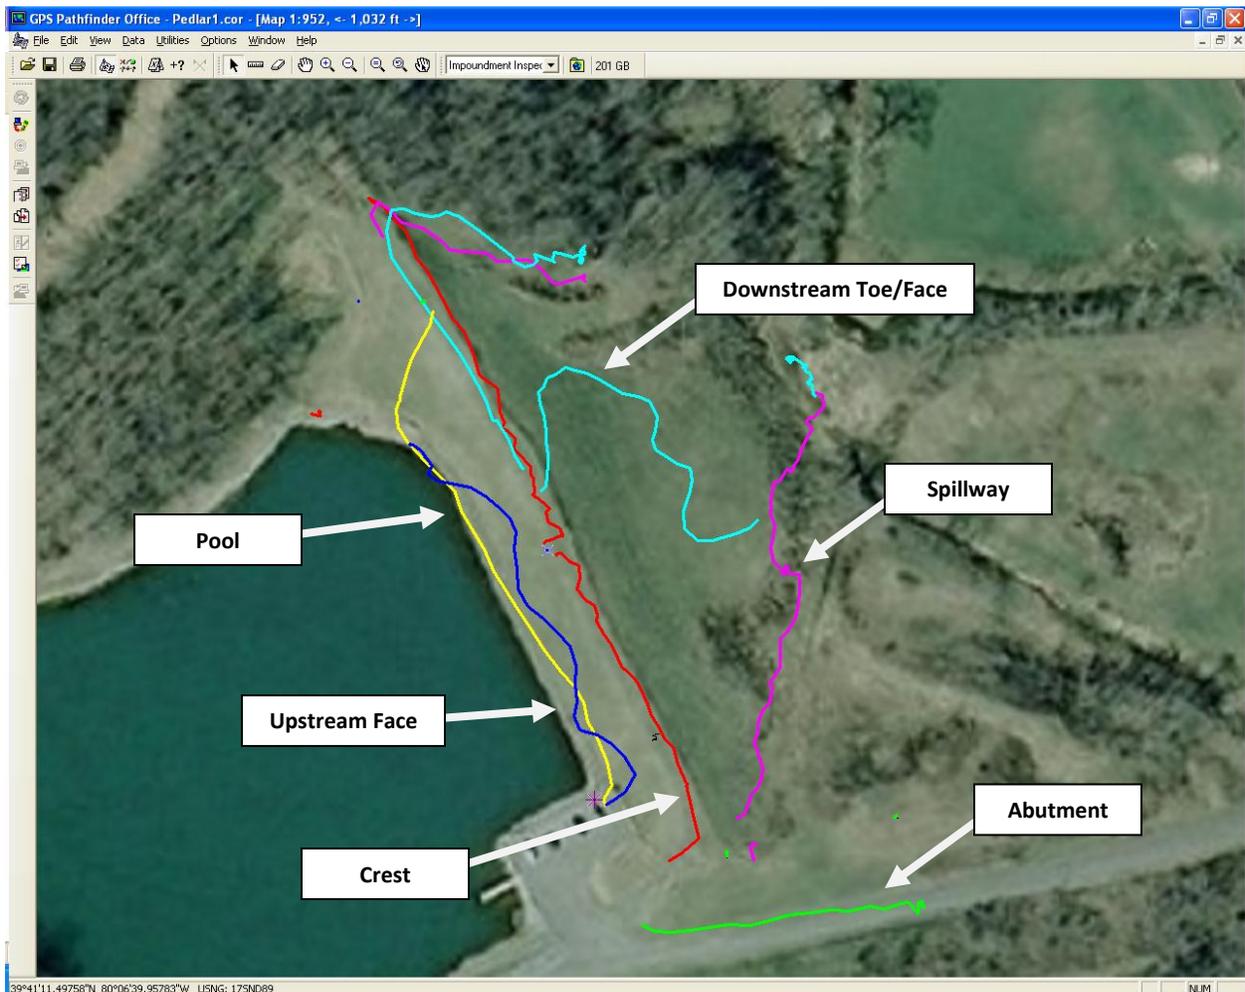
Figure 19: Pedlar1 inspection mapped over aerial imagery.

The first Pedlar inspection (Figure 19) began with an examination of the crest (red). At the midpoint of the crest, a piezometer was in place; therefore, the crest feature was ended and a piezometer feature was created. Following the piezometer recording, a second crest feature was opened in order to record the remaining crest. The left abutment (green), upstream face (dark blue), and impoundment pool (yellow) features were recorded next, completing the upstream face of the impoundment. After completing the breakthrough, return lines, and roadway features, the right abutment was inspected, followed by the left groin ditch (magenta). The downstream toe and face (cyan) was examined as well, and the right groin ditch inspection concluded the full inspection routine.

Section 4.1.1 discusses each inspection performed at the Pedlar WMA, particularly the order that the features were recorded in to demonstrate the discrepancy amongst the inspections. The inspections were performed in alternating orders to show that the template may be used in a manner that best suits the inspector. The results show up identically on a map regardless of the order of which they were recorded. The following aerial images illustrate the inspector learning curve throughout the series as well. Notice how the traveled routes for the second and third inspections do not overlap or cover the same area more than once.

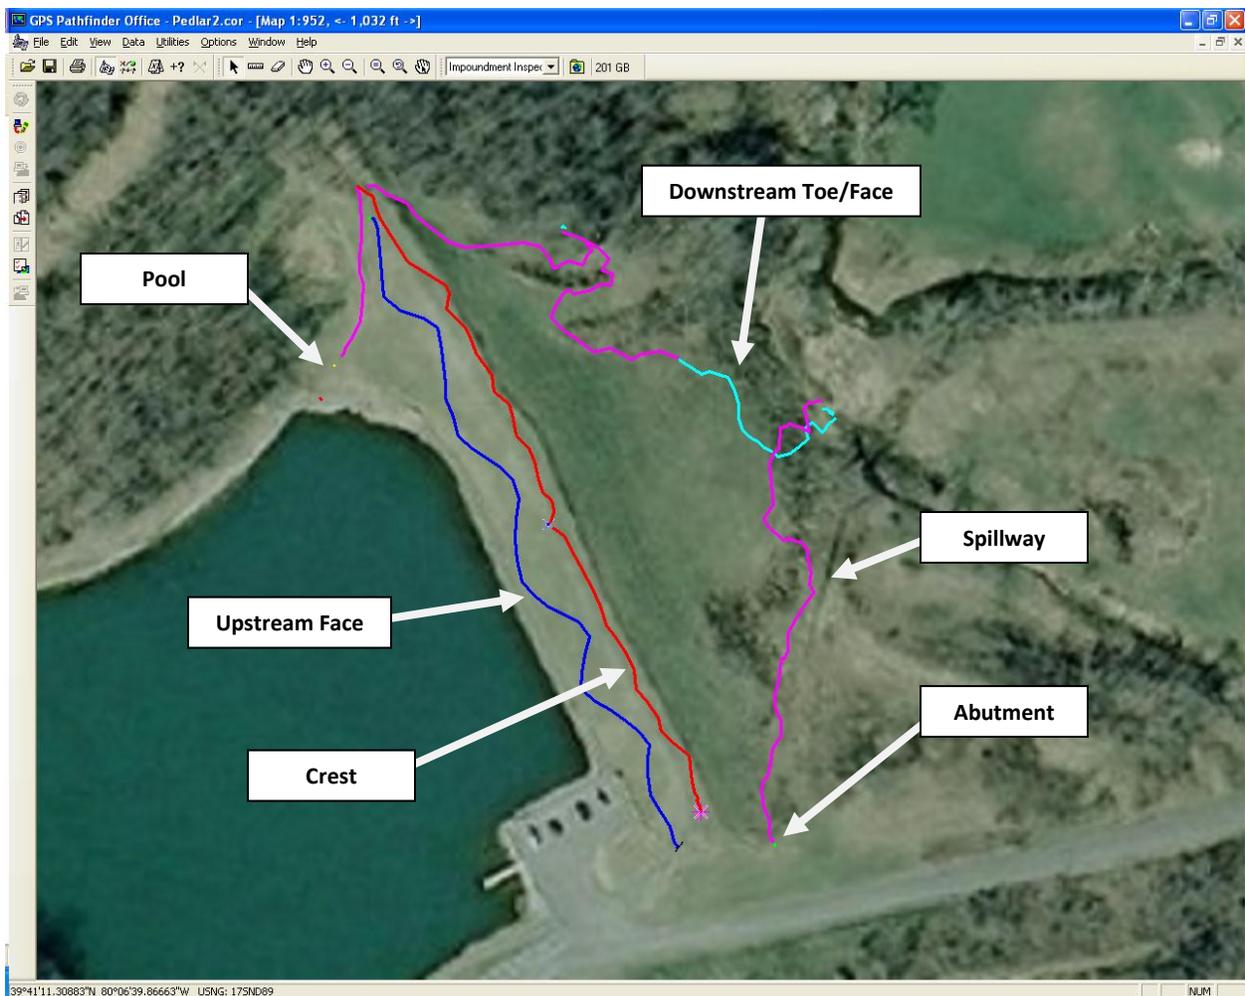
Figure 20: Pedlar2 inspection mapped over aerial imagery.

Similar to the first inspection, the second inspection (Figure 20) began with a crest examination. The piezometer was recorded at the midpoint of the crest feature as it was during the first inspection. On the second inspection, however, a spillway on the north side of the upstream face was encountered. The vegetation was overgrown near the abutments; therefore, the spillway went unnoticed during the first inspection. A quick inspection of the impoundment pool was performed from the north end of the upstream face because it reduced overall time by not traveling across the upstream face twice. Next, the left abutment and upstream face of the impoundment was checked for potential hazards. The questions involving breakthrough, return lines, and roadways were responded to before performing an inspection of the right abutment, and the groin ditches and downstream toe/face completed the second inspection. The second inspection resulted in less time and less distance was traveled due to the increased familiarity of the impoundment.

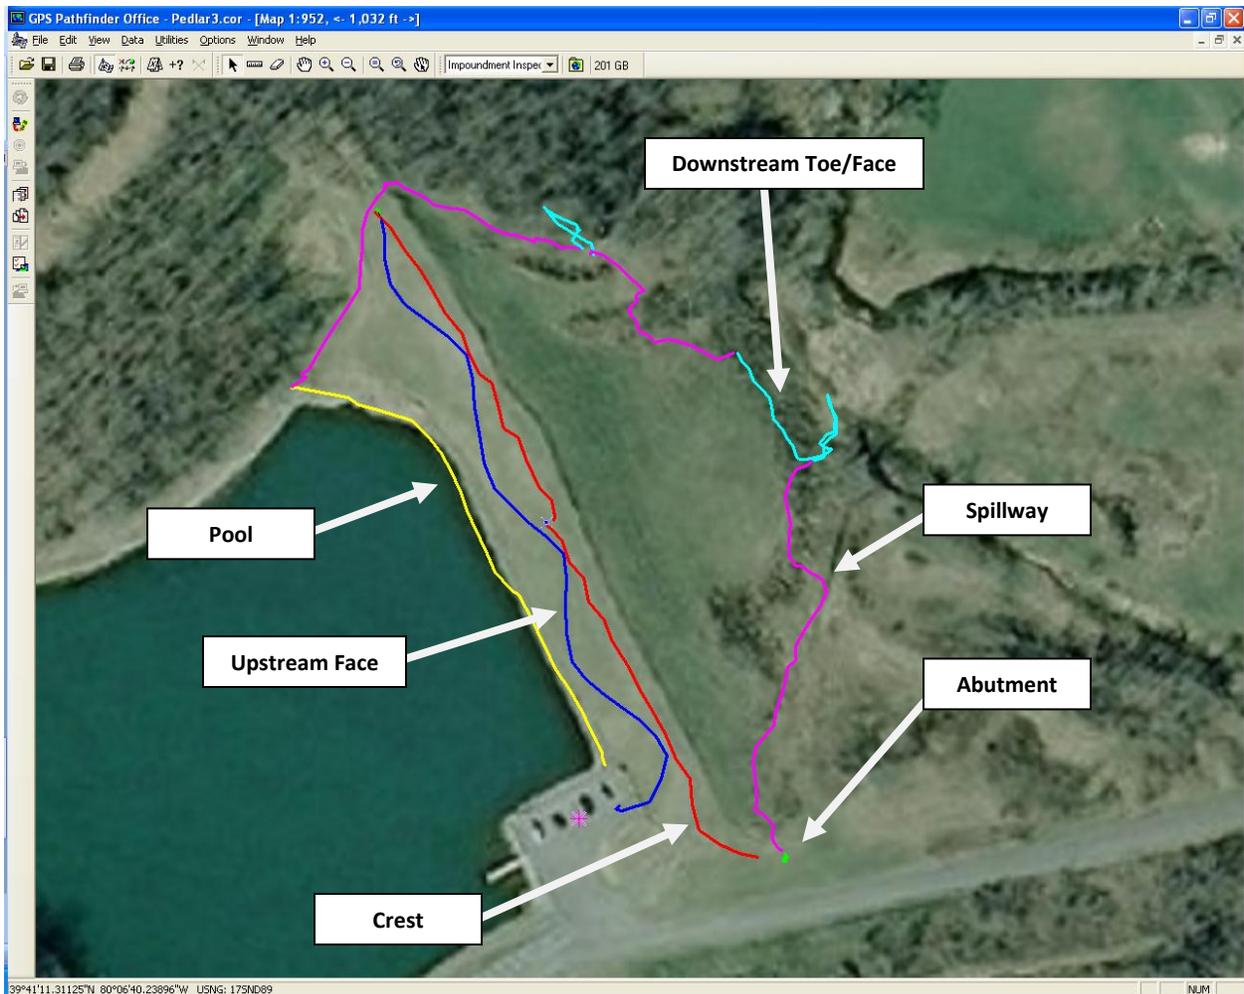
Figure 21: Pedlar3 inspection mapped over aerial imagery.

After the general information was completed for the third inspection (Figure 21), the impoundment pool was examined for any hazards. The spillway at the north end of the upstream face was examined next, followed by the left groin ditch. This ditch could not easily be followed because of the exceptionally overgrown vegetation covering the downstream face of the impoundment. The downstream toe/face was inspected after the left groin ditch, and the right groin ditch was navigated in order to reach the top of the impoundment again. The right abutment was inspected from the top of the right groin ditch, and the crest was examined after along with the piezometer at the midpoint. The inspection continued with the examination of the left abutment and the recording of the breakthrough, return lines, and roadway features. The latter three features are not so important to this impoundment as there are no return lines or mines adjacent to the impoundment, and the roadways are paved and well maintained. The inspection was completed with the assessment of the upstream face. The total time to inspect the
