Mine Safety Impoundment Inspection and Verification Tool: Phase I Final Report

Mining and Industrial Safety Technology and Training Innovation (MISTTI)

Keywords: coal impoundment, impoundment inspection, dam safety

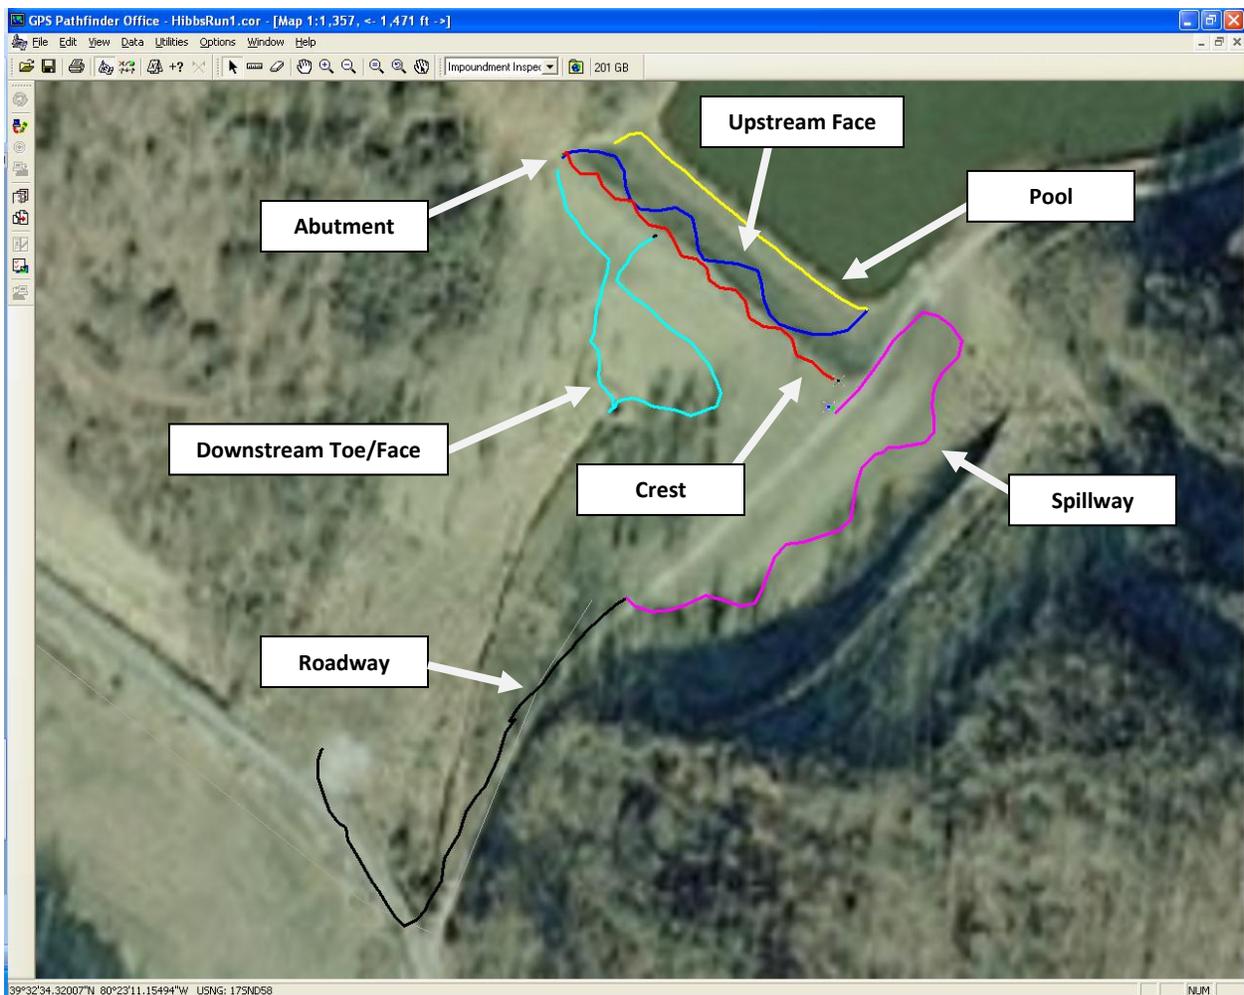
Figure 24: HibbsRun1 inspection mapped over aerial imagery.

The first inspection at Hibbs Run began with completion of the general information. The first feature in Figure 24 recorded for the impoundment was the crest (red), which unlike the Pedlar site, could be

entirely recorded at once. This reduced the number of features to work with back in the office. After the crest was examined, the left abutment (green) followed. From the left side of the impoundment, the upstream face (dark blue) was recorded. The waterfront was inspected after under the impoundment pool (yellow) feature. The downstream toe (cyan) and face was assessed next by traveling over the downstream face to the outlet and back. The breakthrough and return line features were recorded next, which posed no significance because there are no mines or return lines adjacent to the site. The only piezometer on site was recorded at the left side of the crest, as was the left abutment. The walk from the impoundment consisted of recording the left spillway (magenta) and the roadway (black) leading out of the site.

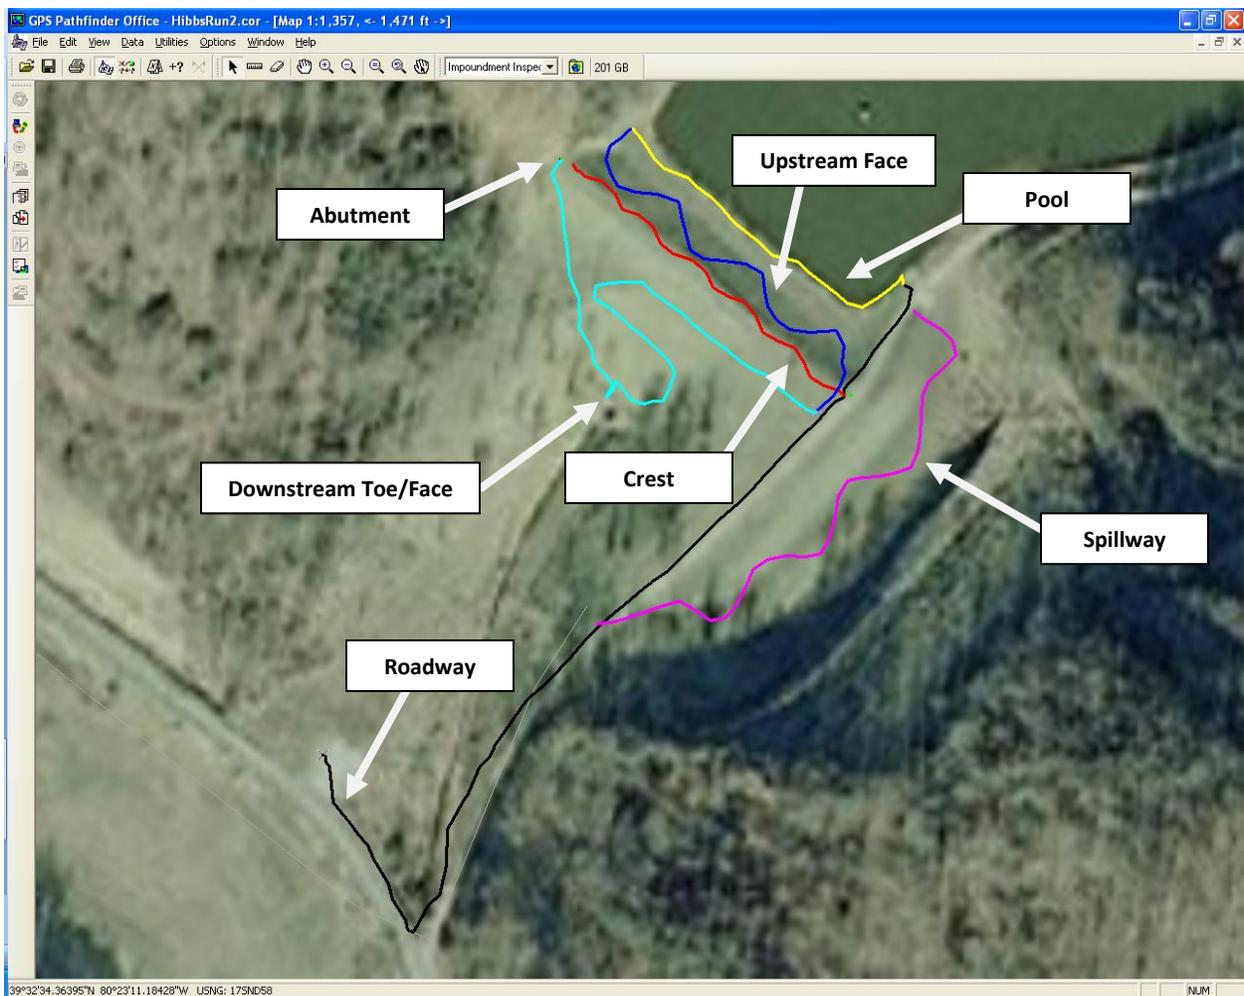
Figure 25: HibbsRun2 inspection mapped over aerial imagery.

The second inspection (Figure 25) consisted of recording the roadway feature on the way into the impoundment, which differed from the order of the first inspection. The roadway was traveled down to

the impoundment pool, which was recorded next. From the right side of the impoundment, the upstream face was navigated and inspected, followed by the piezometer and then the downstream toe/face, which was traveled differently than before. Breakthrough and return line features were recorded after the downstream toe area. Then, the right abutment was inspected and the crest was navigated in the opposite direction from before. The left abutment and spillway were examined to complete the inspection, which only totaled about 28 minutes.

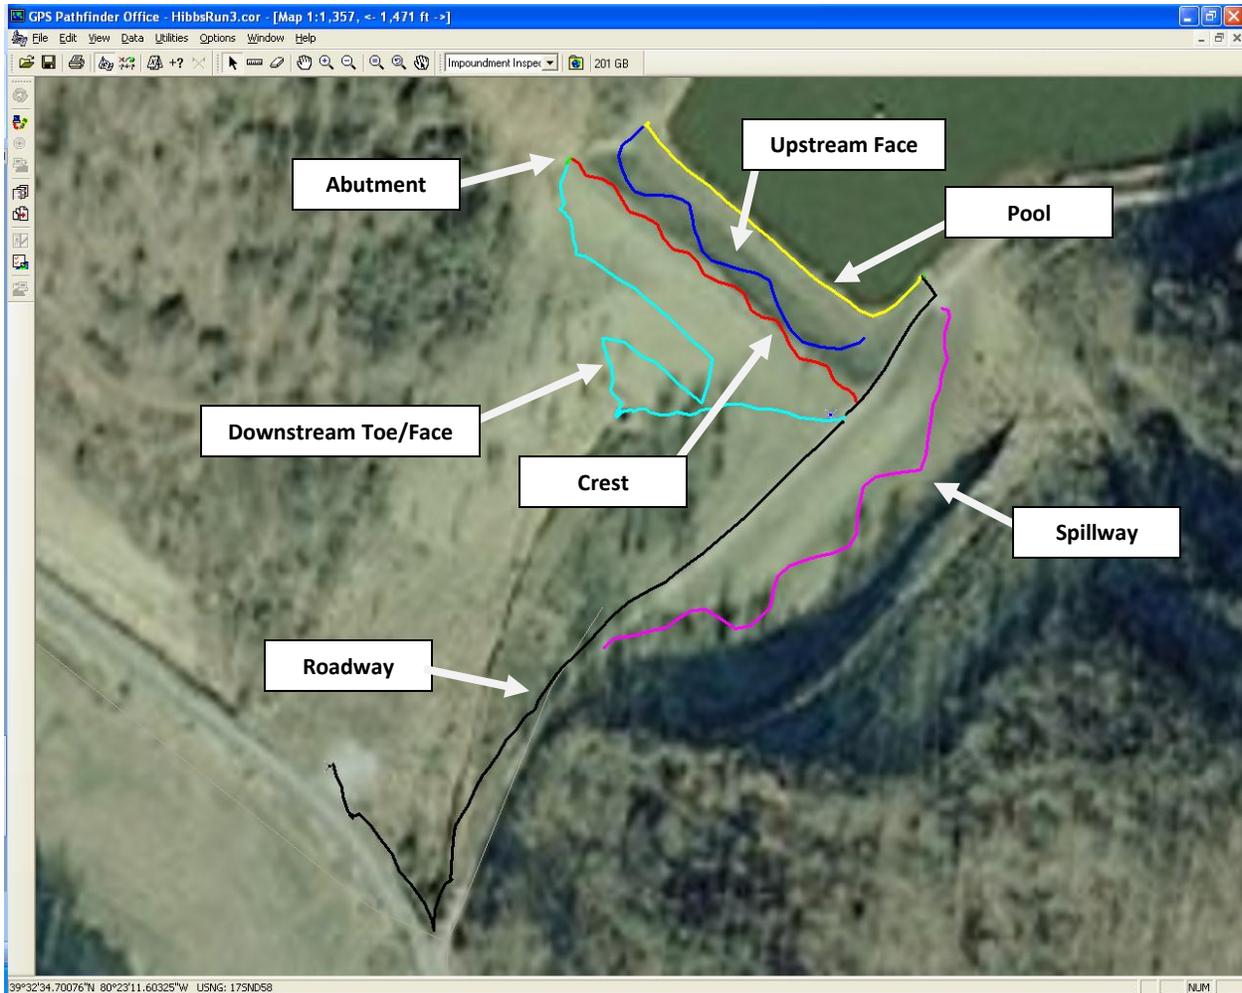
Figure 26: HibbsRun3 inspection mapped over aerial imagery.

The third inspection (Figure 26) of Hibbs Run began with the roadway inspection once again, which followed completion of the general information feature. The piezometer was recorded next, and the crest followed. The right abutment was assessed for hazards preceding the navigation over the downstream face of the structure. The downstream face was traveled differently again, making sure that all area was covered between the three inspections. After arriving at the crest of the impoundment

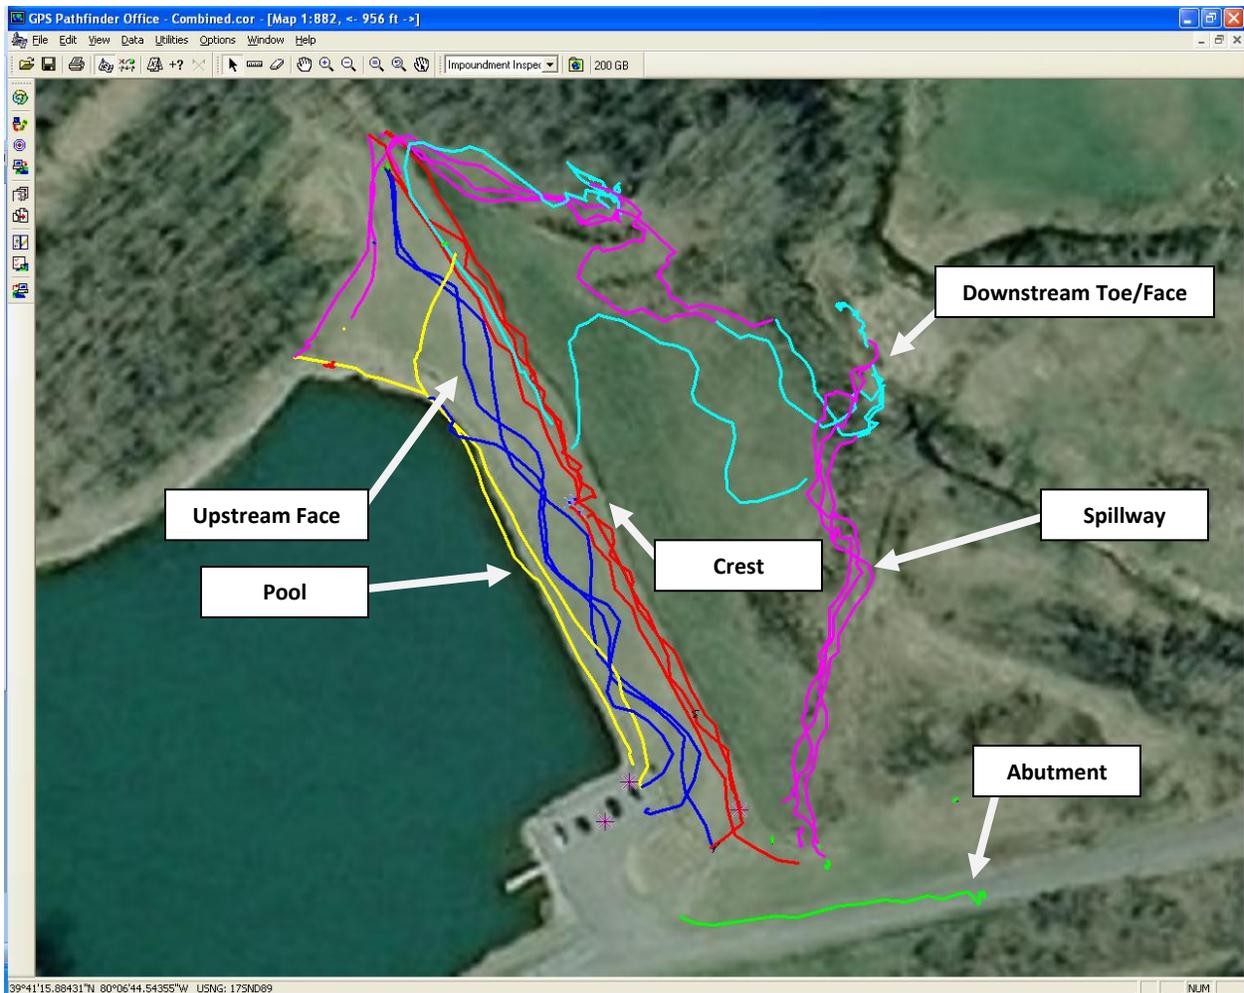
Figure 29: Combined map of Pedlar inspections over aerial imagery.

Combining inspection files may be beneficial to the industry because of its ability to show the multiple routes traveled over time. The maps are proficient at demonstrating either the consistency or the randomness of the routes walked over the retention structure. Figure 29 shows the series of three inspections performed at Pedlar WMA while the second is of the series performed at Hibbs Run impoundment. Notice how the downstream face of the Pedlar impoundment was only traveled one of the three times, while the downstream face of the Hibbs Run impoundment was covered in a different manner each time. These types of features are essential to proper inspection, and using a combined map of inspection routes will identify missed or skipped areas on any impoundment inspection.
